PHOTOGRAPHS

OF THE

ATOMIC BOMBINGS

HIROSHIMA AND NAGASAKI

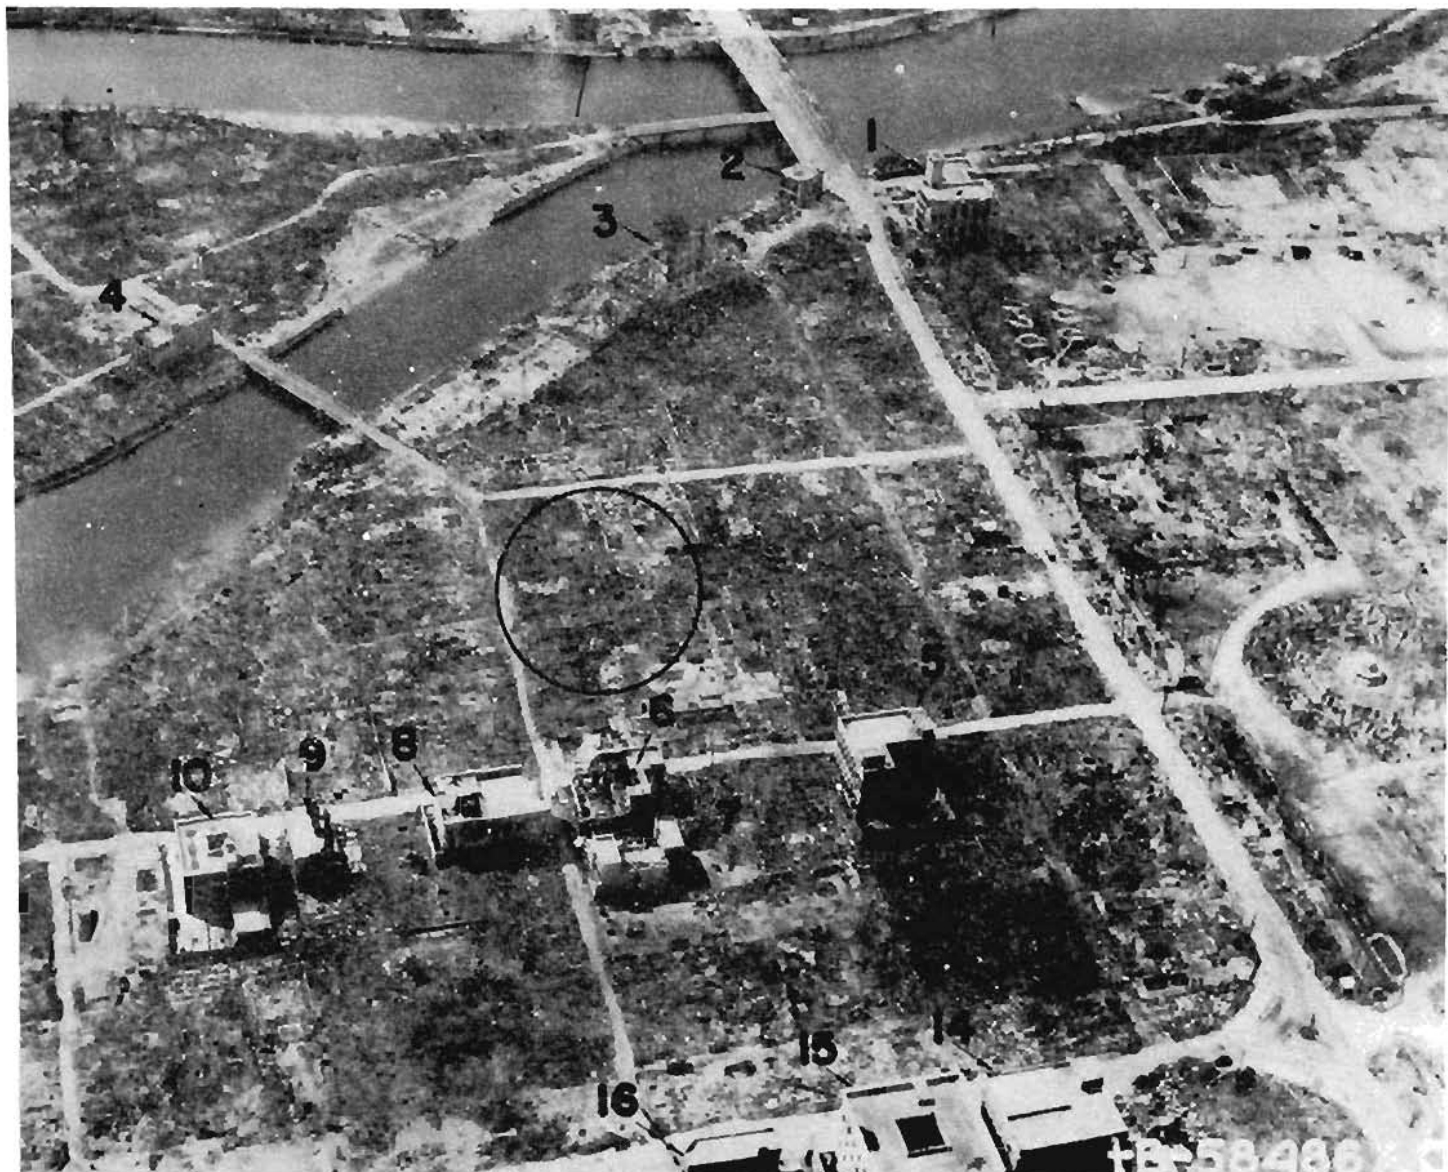
Figure 19

Aerial view looking directly down on X in Hiroshima, showing the target area completely leveled except for reinforced concrete building frames. Roofs and intermediate floors collapsed on five of these buildings leaving the exterior walls partially standing. The dark spots on the roofs of other buildings are depressions formed by the downward distortion of the roof structure.

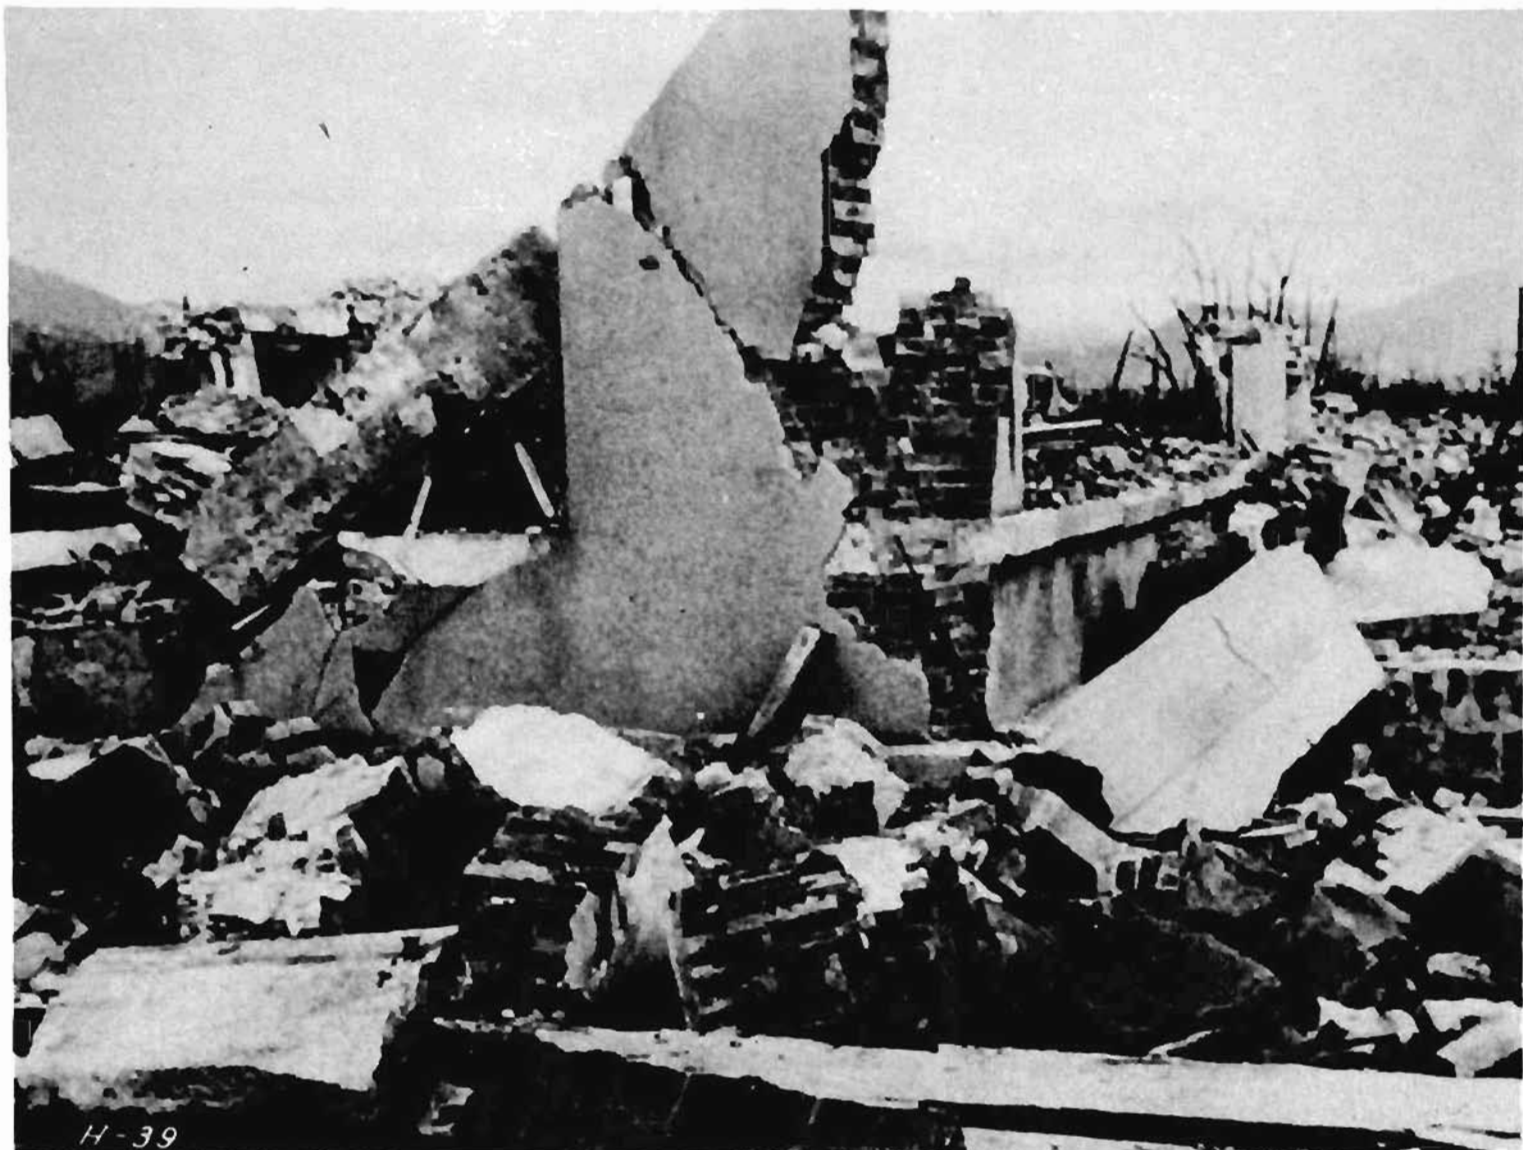
Figure 22

Looking east from X. The trunk of a small tree standing in the foreground indicates that the force of the blast was directly downward in this area.

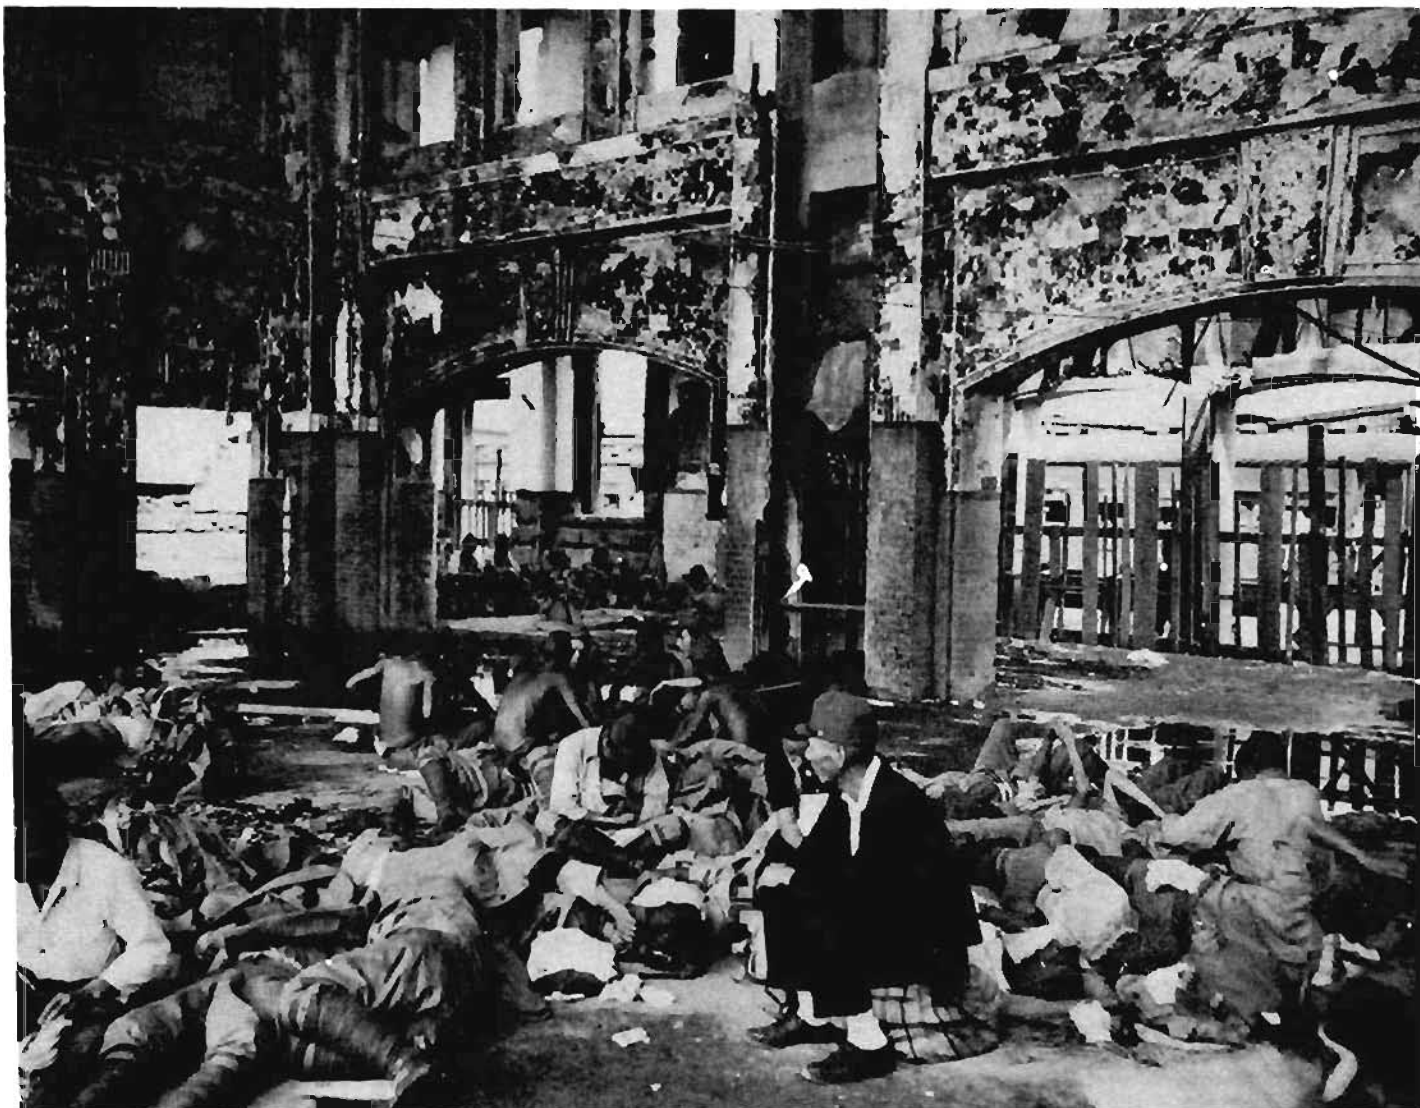
Figure 36

University of Hiroshima, 0.8 to 0.9 mile south of X, looking northeast from the Red Cross Hospital. The buildings shown were of reinforced concrete construction and were not severely damaged structurally. Other buildings in this group were of wooden construction and were destroyed by blast and fire. The buildings still standing were gutted by fires of secondary origin. The end walls of two otherwise demolished buildings may be seen in the center background; these walls are parallel with the direction of the blast which was from left to right.

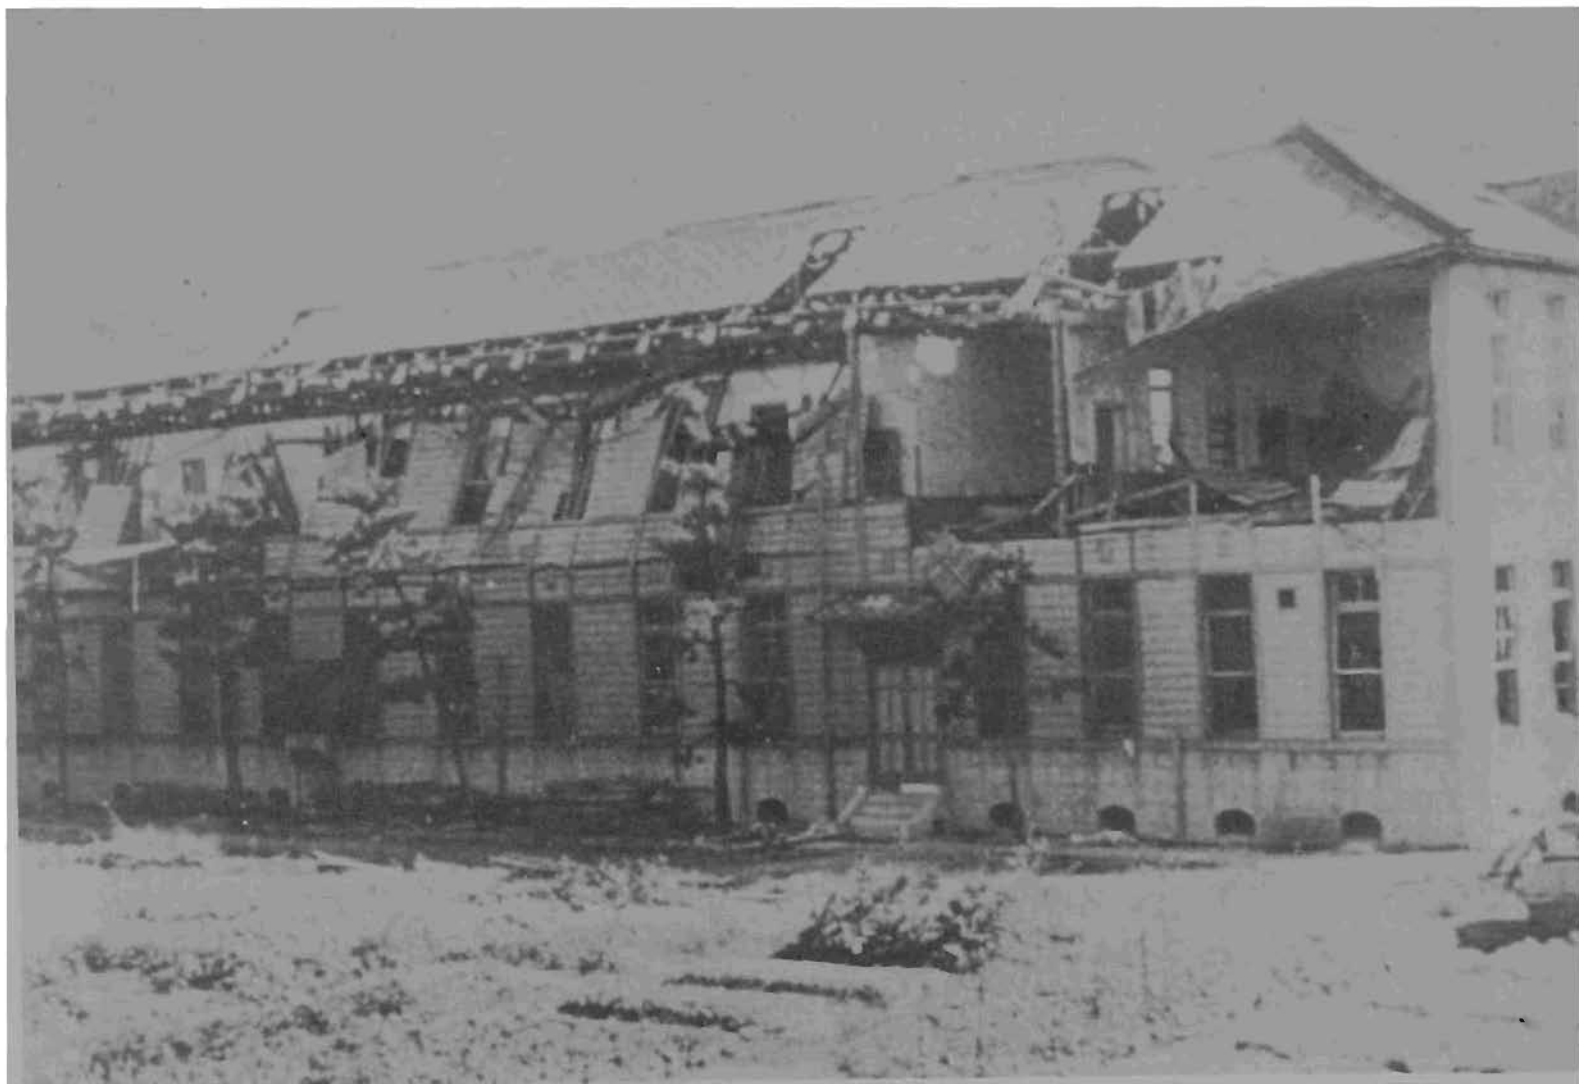
Figure 38

This view shows damaged buildings which are generally classified as "moderate blast damage to frame buildings", and is typical of damage to frame buildings 1.25 to 1.50 miles from X in Hiroshima.

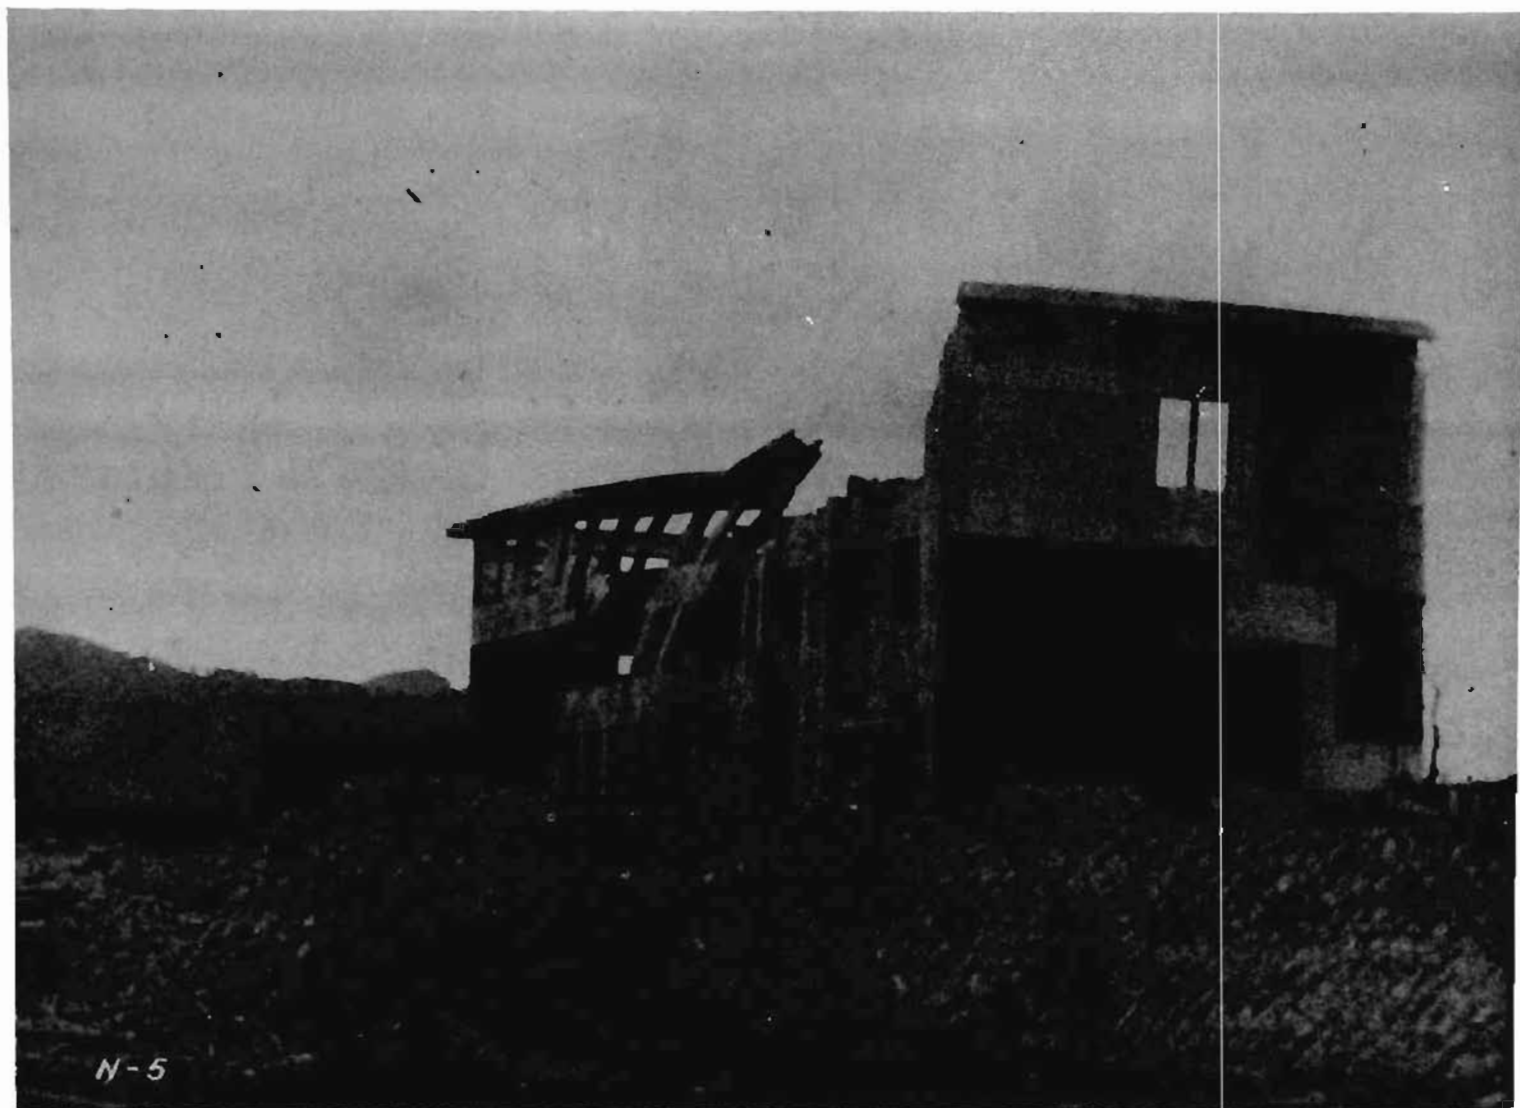
Figure 55

Reinforced concrete school building, 0.3 mile southwest of X. This building was used as a factory training school. The damage on the left end resulted from a parapet wall pulling loose. Damage on the right end was caused by failure of wall columns which permitted collapse of structural steel roof trusses.

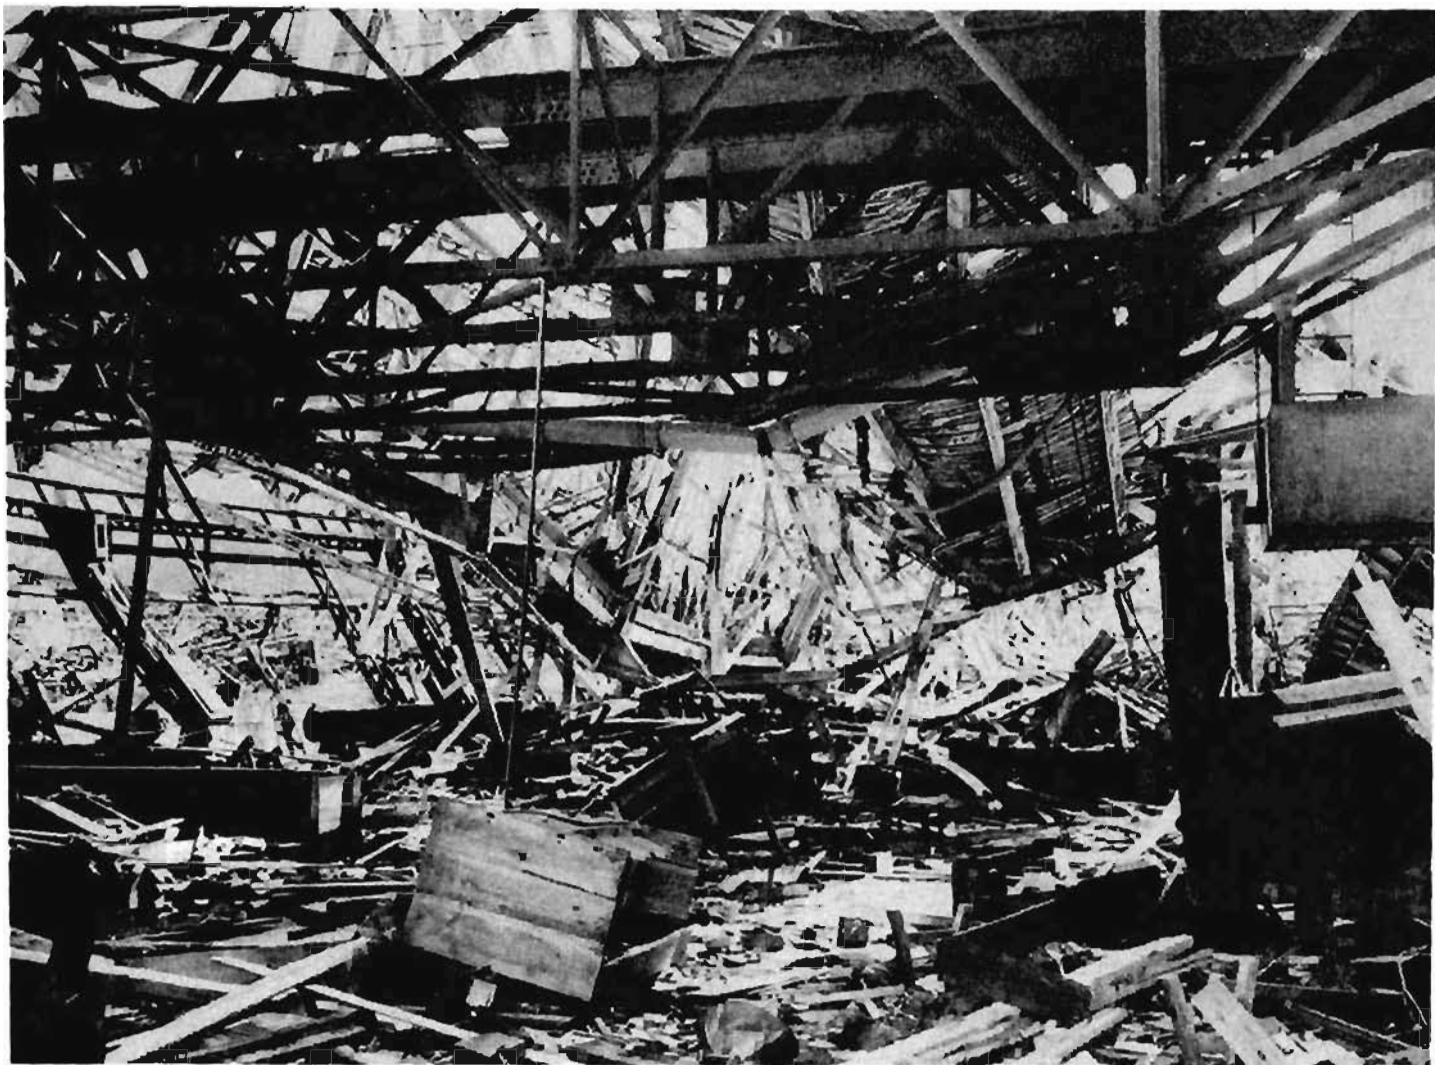
Figure 60

A view of one of the factory buildings with saw-tooth roof truss in the Mitsubishi-Urakami Ordnance Works, 0.9 mile from X. These trusses were very lightly constructed of light steel members. The roof failed from the thrust of the bomb blast, and its failure collapsed the purlins and caused the roof to fall in generally.

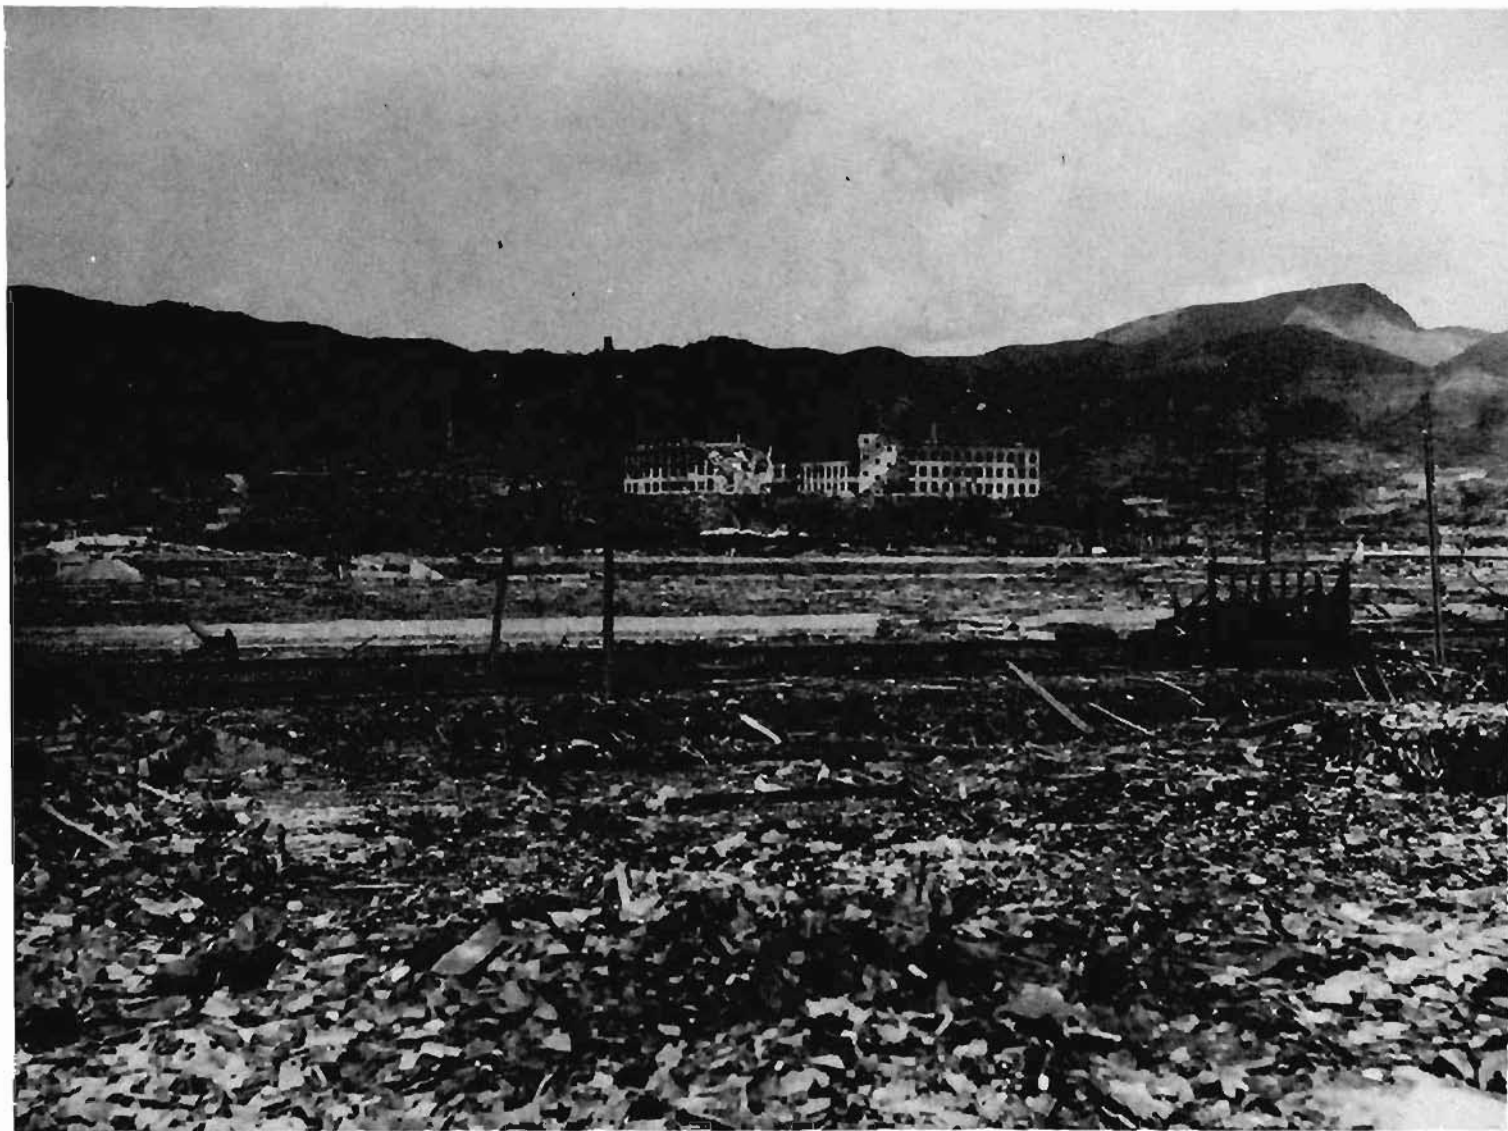
Figure 89

A wood working plant, 6,000 feet south of X in Nagasaki. Very heavy fire damage was experienced here.

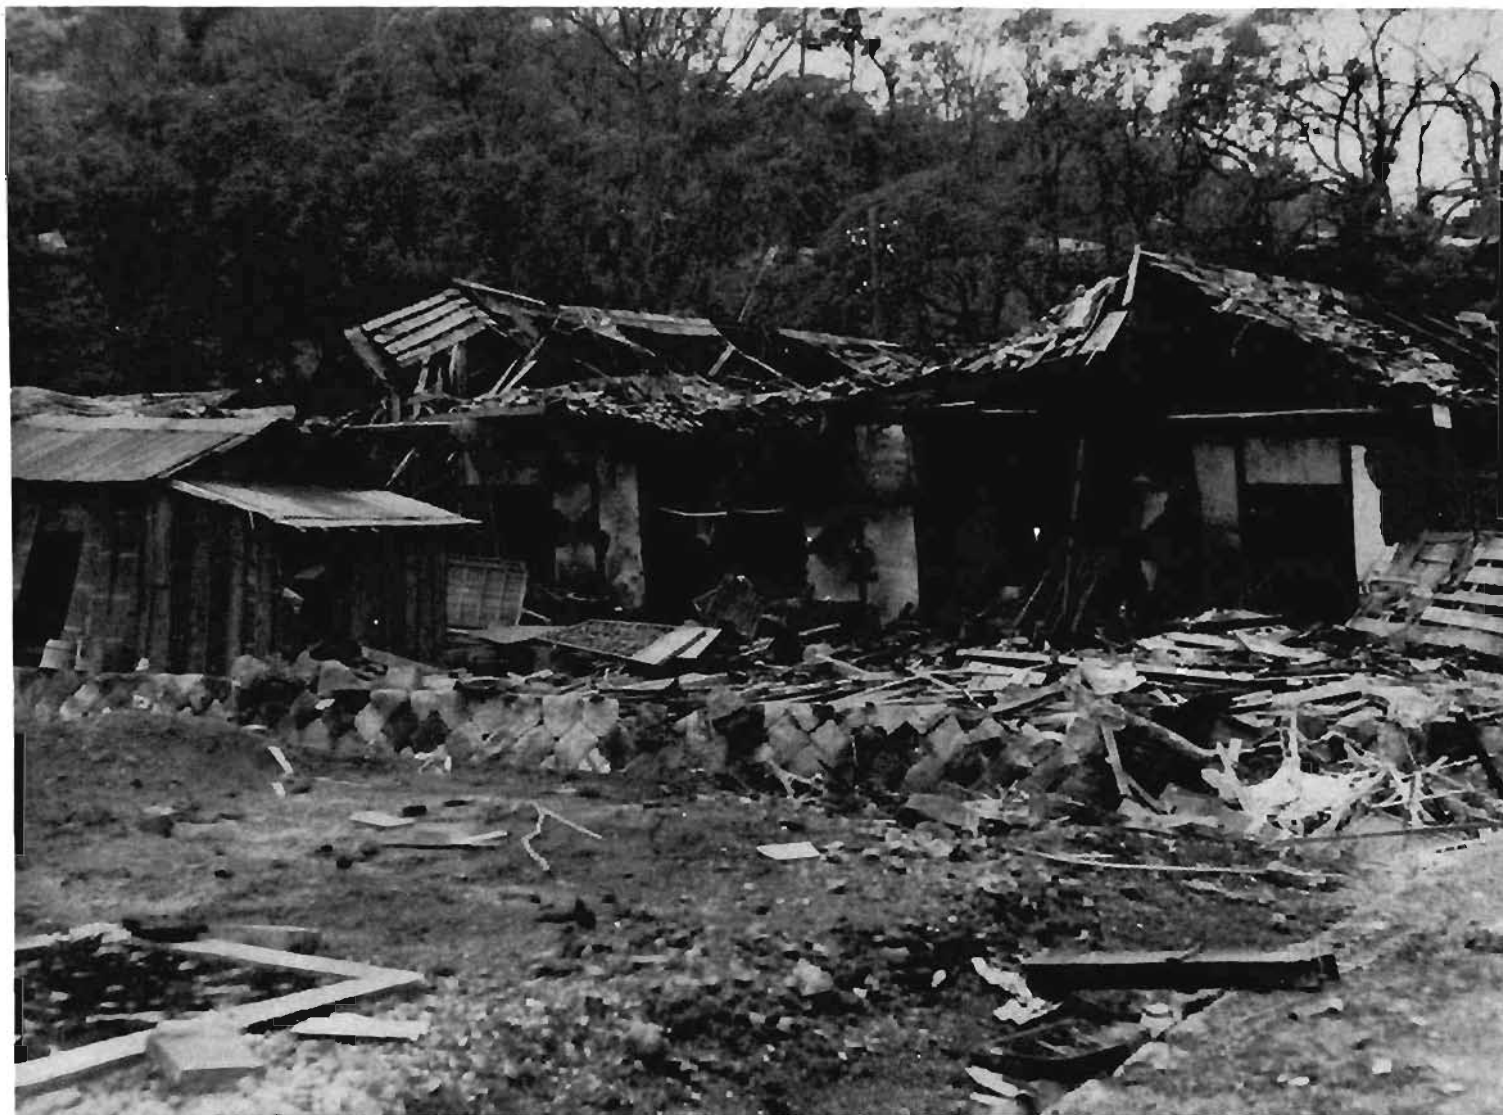
Figure 100

Damage to tile roof 11,000 feet south of X in Nagasaki.
