TARGET NO. 1627 NAME Omura A/C Factory, Omura ZONE 12
90.36

DAMAGE ASSESSMENT REPORT NO. 33

This report assesses damage to Target 1627 resulting from XXI Bomber Command Mission 46 of 27 March 1945.

TARGET NO. 90.36 - 1627
90.36 - 849

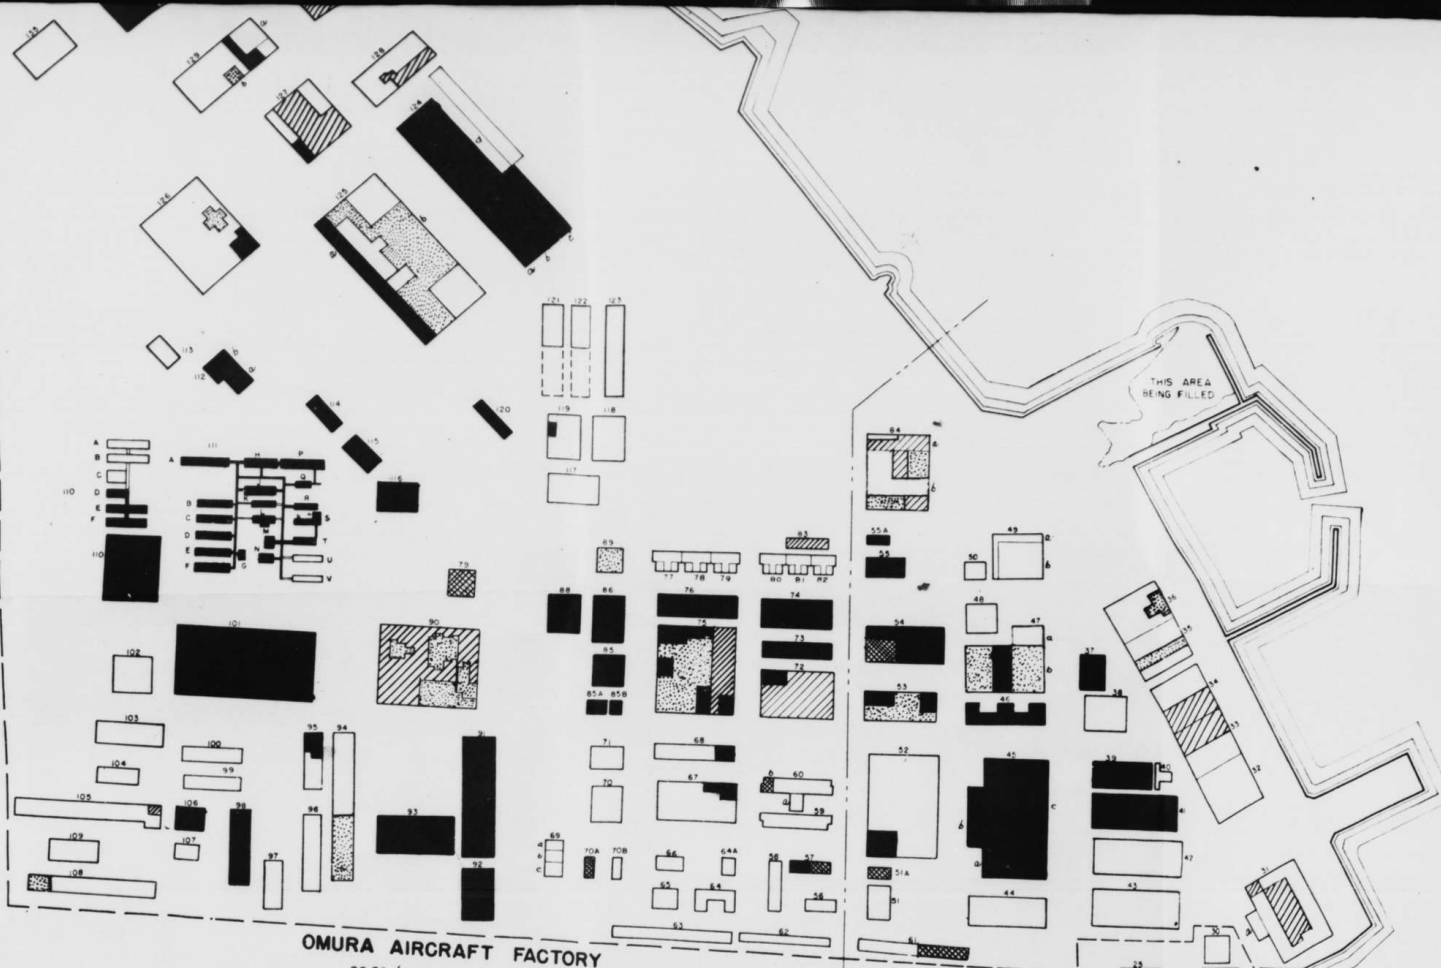
OMURA AIRCRAFT FACTORY
90.36/1627

BUILDING		VISIBLE DAMAGE		DESCRIPTION OF DAMAGE			
REF. NO.	AREA	STRUCT'L	SUPERF'L				
1-30	550.9	91.8		OMURA Naval Air Station, 90:36/849, unchanged from previous reports. Target cloud covered and a study cannot be made.			
31	77.5		32.0	Roof damage to center of building			
32	5.8			Rest of roof possibly disturbed			
33	41.0		20.5	Undamaged			
34	41.0		20.5	South half of roof damaged			
35	41.0		7.6	North half of roof damaged			
36	41.0		5.5	Damaged prior to 10 Dec 1944			
37	11.5	11.5		Damaged 27 March 1945			
38				Damaged prior to 10 Dec 1944			
39	21.0	21.0		Undamaged			
40				7.0 damaged 27 March 1945; 14.0 prior to 10 Dec 44			
41	44.0	44.0		Undamaged			
42	48.5			Damaged 27 March 1945			
43	48.5			Undamaged			
44	32.0			"			
45	114.5	114.5		Damaged prior to Dec 1944			
46	17.0	17.0		" " " " "			
47	47.5	12.0	35.5	" " " " "			
48				Undamaged			
49				"			
50				"			
51				"			
51A	3.2	3.2		Demolished			
52	100.0	11.0		Damaged 27 March 1945

Structural Damage to Date	1300.9
Superficial damage to Date	627.5
TOTAL DAMAGE	1928.4

Net Damage <u>after</u> 27 March 1945	300.7
to coverage date, 10 June 1945

LIMITED DAMAGE INTERPRETATION NO. 81
STATS AS OF 25 JUNE 1945
COVER USED:
3PH/5V 299, 2V: 10-11

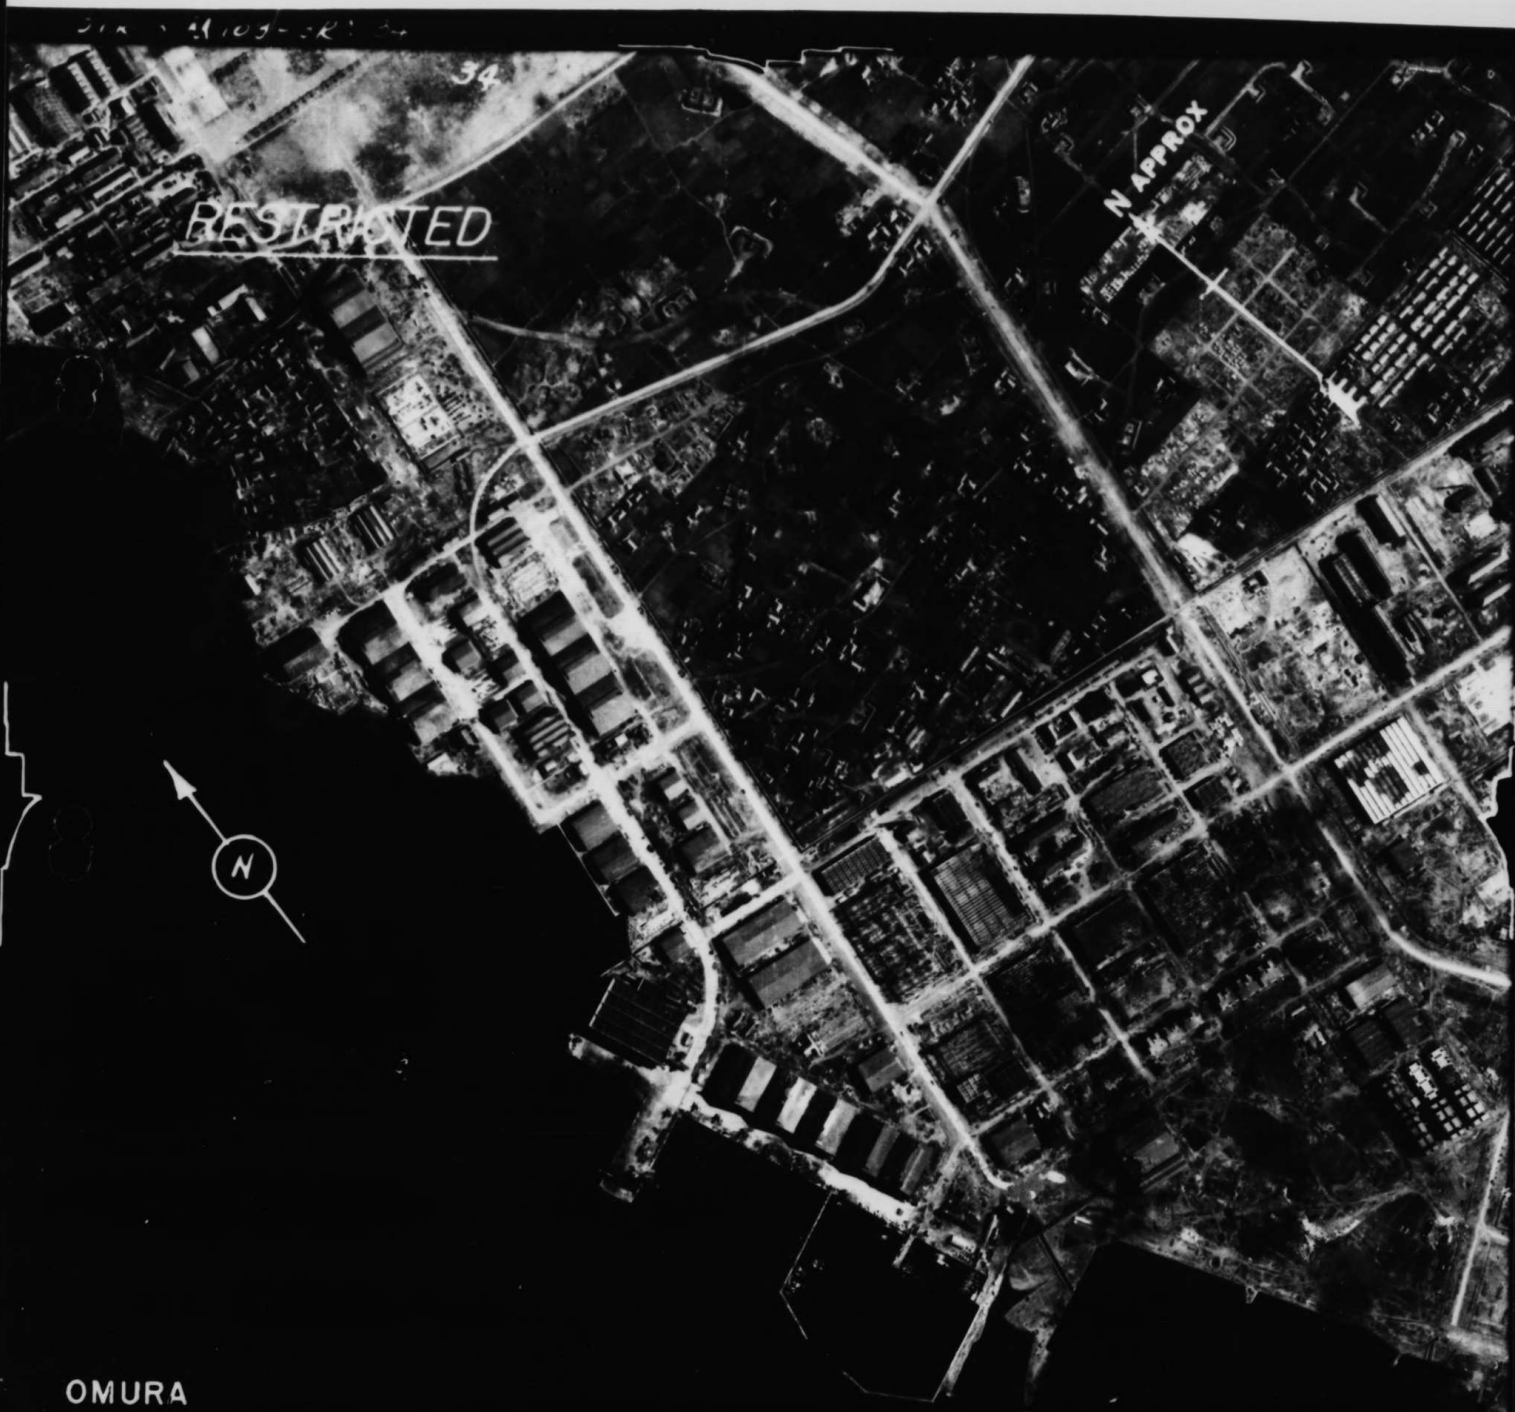
OMURA
POST STRIKE
28 MARCH 1945

This report assesses damage to Target 1627 resulting from XXI Bomber Command Mission 46 of 27 March 1945.

Total damage is about 257,000 square feet or 9.1 percent of the total original roof area of the plant.

New damage is concentrated in the center of the plant's hitherto undamaged portion: administration and plant maintenance, engine repair, original aircraft assembly sections (see reference a).

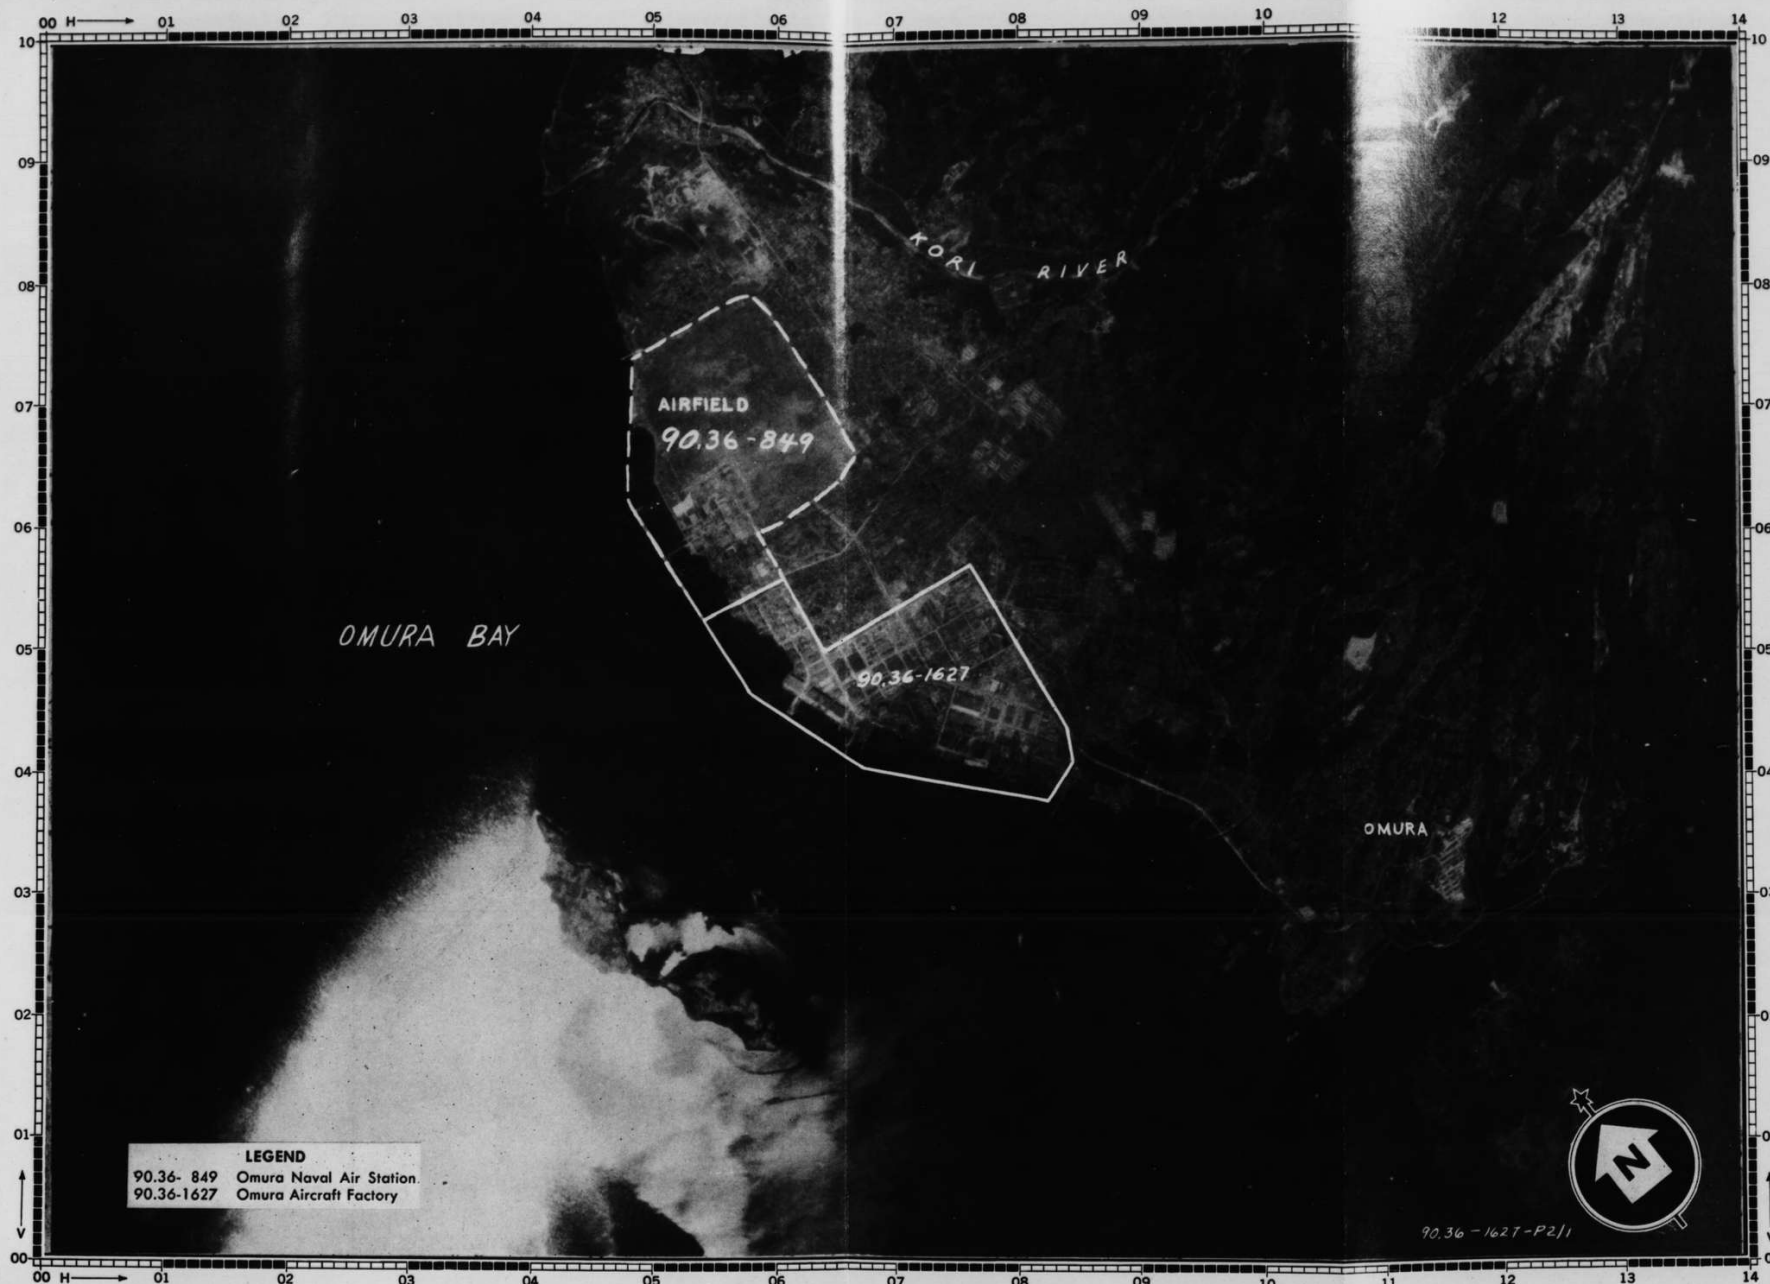
ILLUSTRATION No. . . . **90.36-1627 P2**
DATE. **29 April 1945**
TARGET No. **90.36-1627**
COORDINATES. . . **32°55'N 129°56'E**
PHOTOGRAPHED. . . **21 August 1944**

LEGEND
90.36- 849 Omura Naval Air Station.
90.36-1627 Omura Aircraft Factory

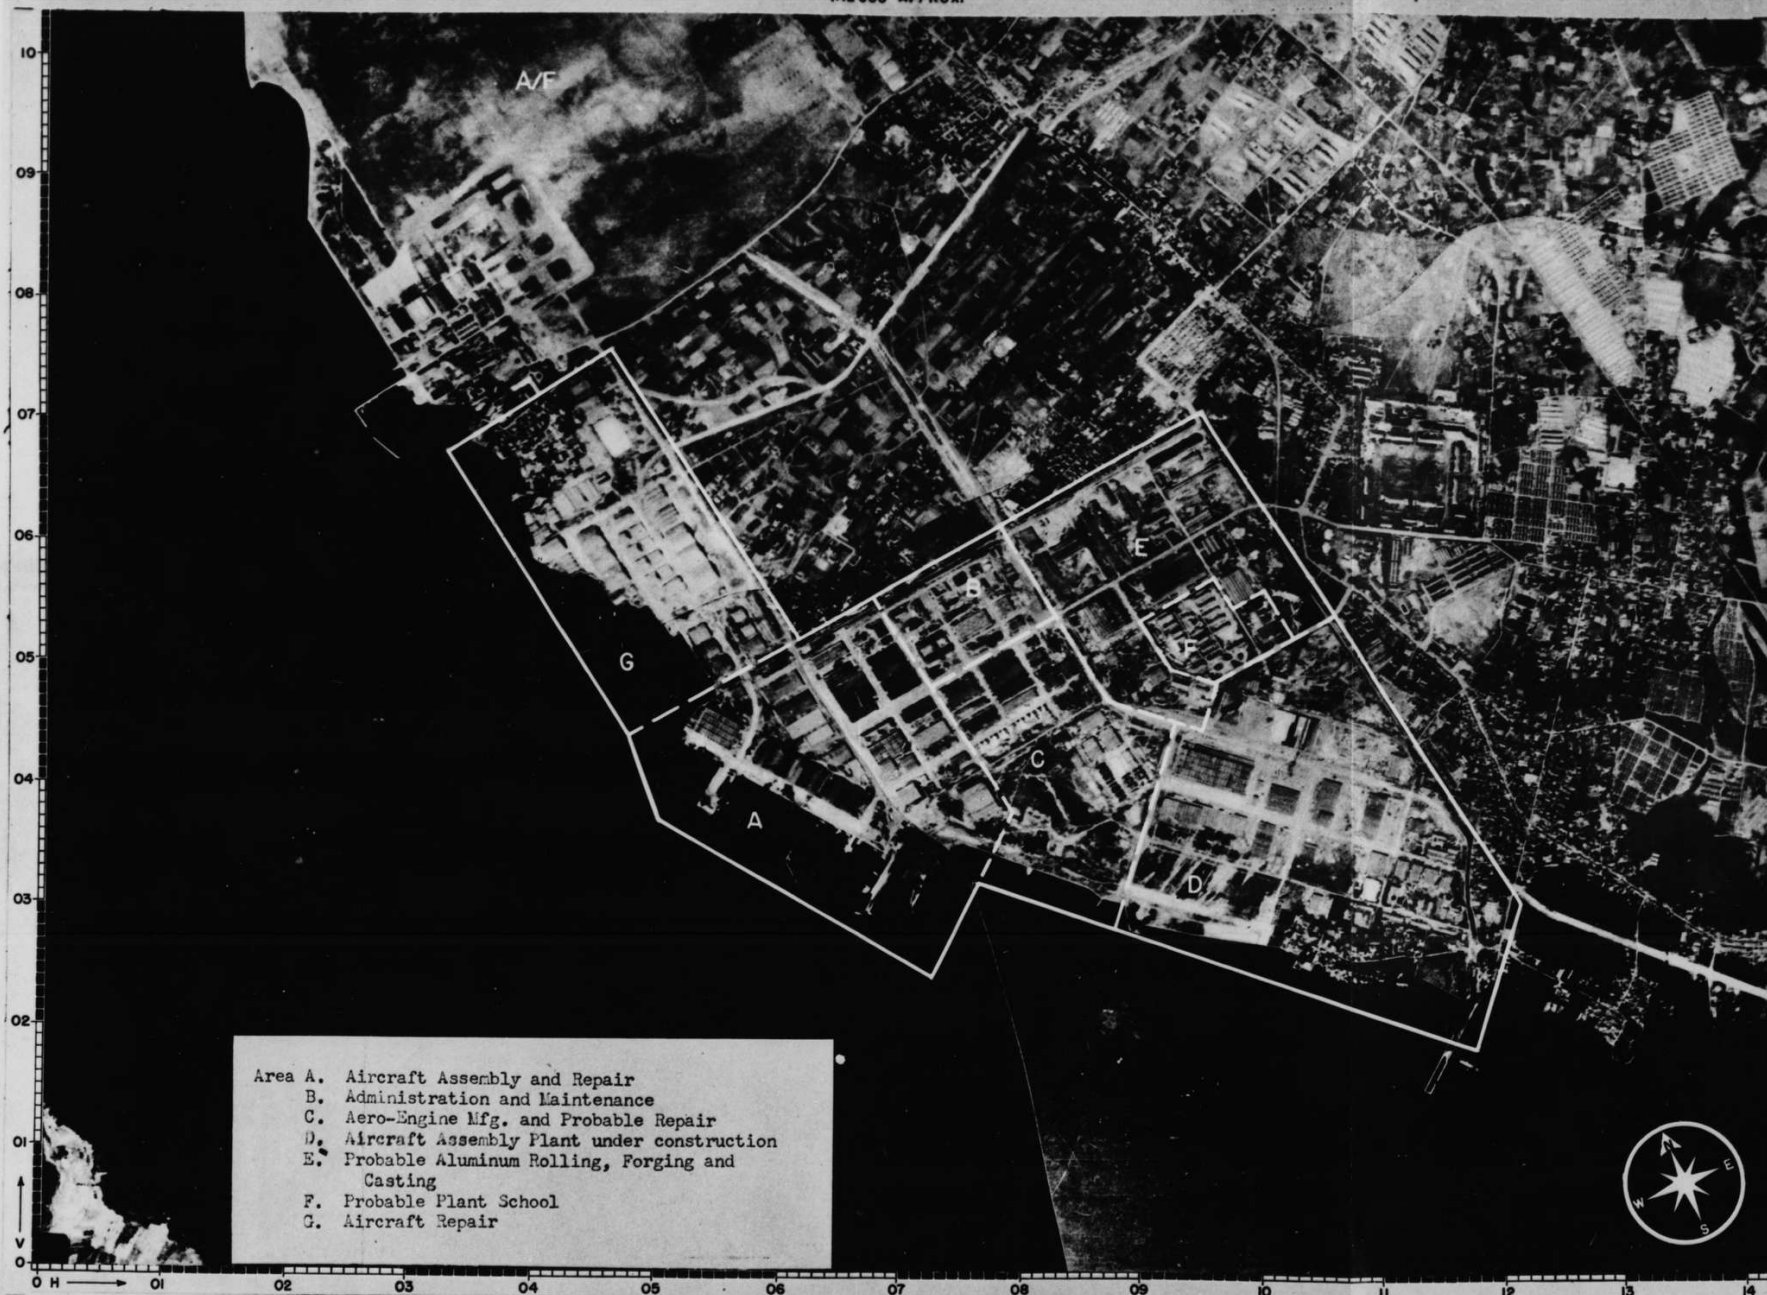
- Area A. Aircraft Assembly and Repair
B. Administration and Maintenance
C. Aero-Engine Mfg. and Probable Repair
D. Aircraft Assembly Plant under construction
E. Probable Aluminum Rolling, Forging and Casting
F. Probable Plant School
G. Aircraft Repair

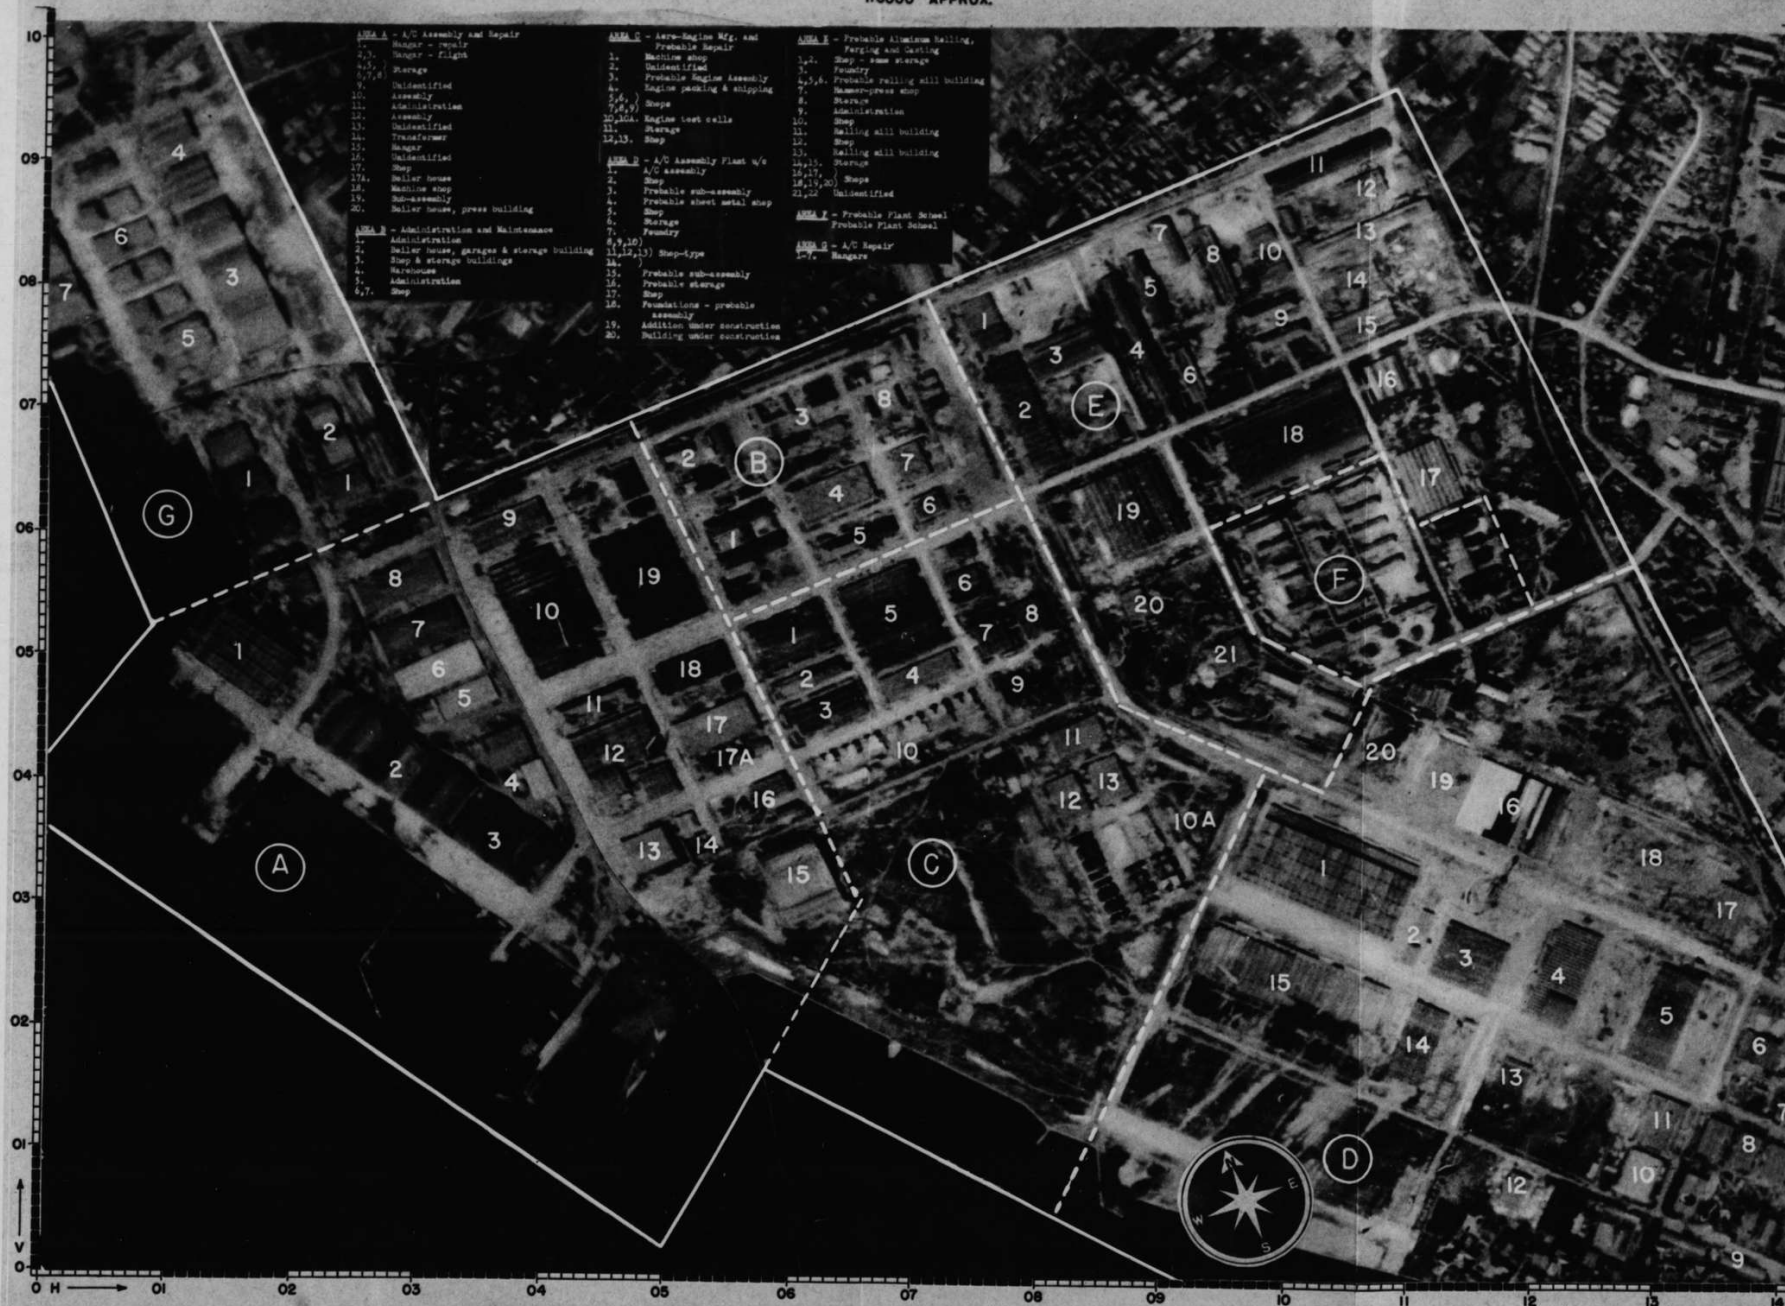
AREA A - A/C Assembly and Repair
 1. Hangar - repair
 2. Hangar - flight
 3. Storage
 4. Unidentified
 5. Assembly
 6. Administration
 7. Assembly
 8. Unidentified
 9. Transformer
 10. Unidentified
 11. Unidentified
 12. Shop
 13. Miller house
 14. Machine shop
 15. Sub-assembly
 16. Miller house, press building
 17. Administration and Maintenance
 18. Administration
 19. Miller house, garages & storage building
 20. Shop & storage buildings
 21. Warehouse
 22. Administration
 23. Shop

AREA B - Intra-Engine Mfg. and Probable Repair
 1. Machine shop
 2. Unidentified
 3. Probable engine assembly
 4. Engine packing & shipping
 5. Shop
 6. Shop

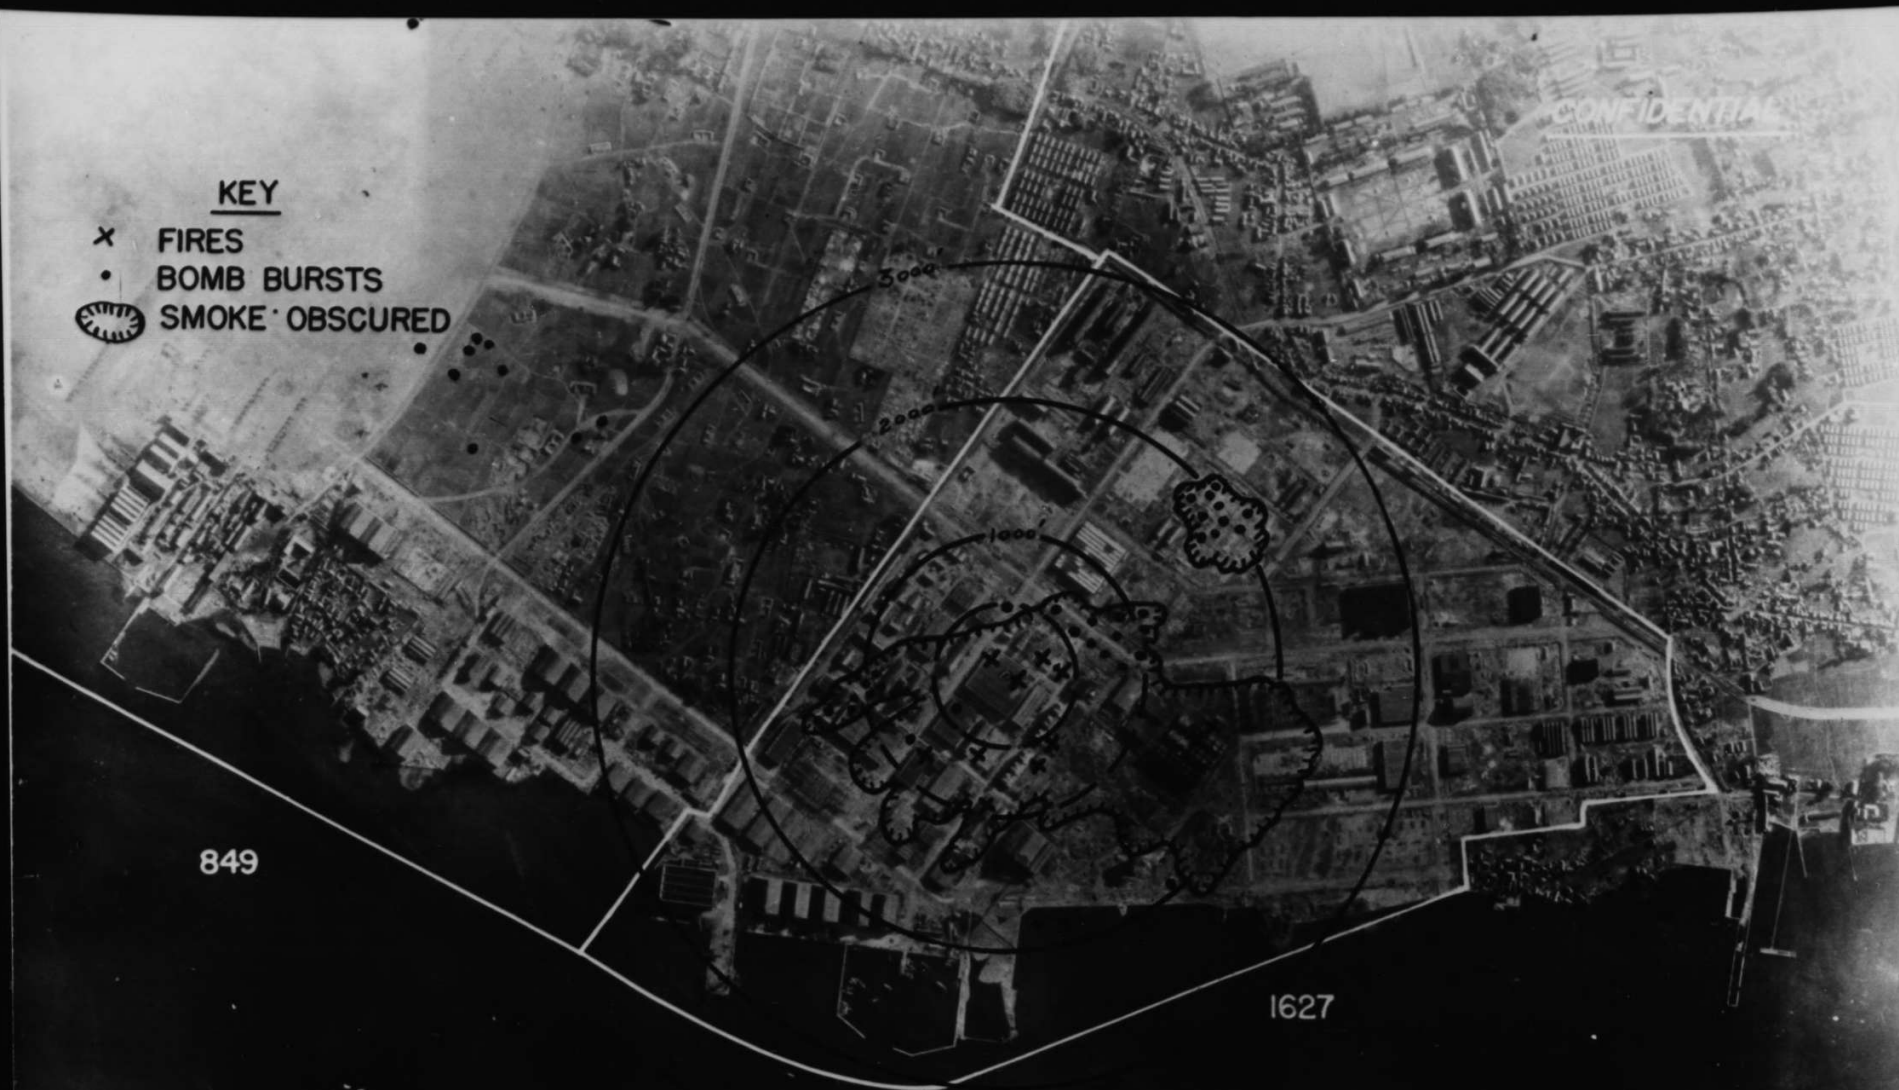
OMURA NAVAL AIR STATION (849)
OMURA AIRCRAFT FACTORY (1627)
STRIKE ATTACK REPORT NO. 6
XXI B.C. MISSION NO. 46-27 MARCH 1945
C.I.U. - XXI BOM. COM.

- x FIRES
- BOMB BURSTS
-
