PHOTOGRAPHS

OF THE

ATOMIC BOMBINGS

HIROSHIMA AND NAGASAKI

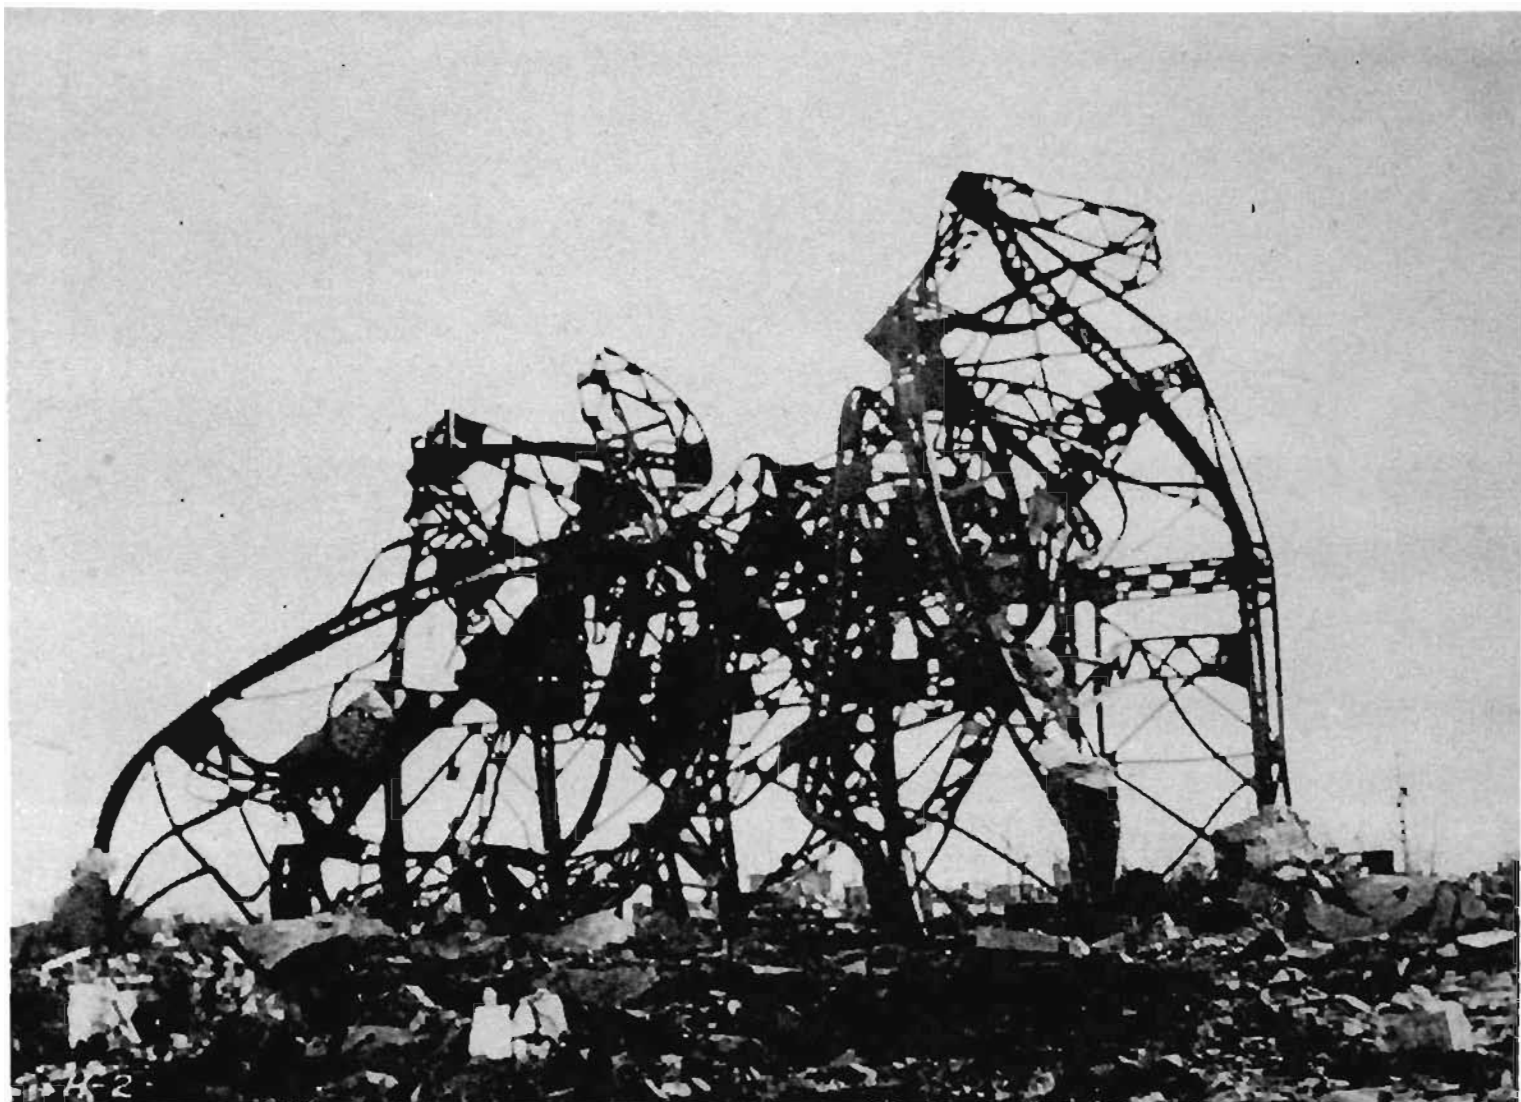
Figure 42

Steel-Framed building, 0.3 mile east of X in Hiroshima. The entire framework of this building was distorted downward in the direction of the blast.

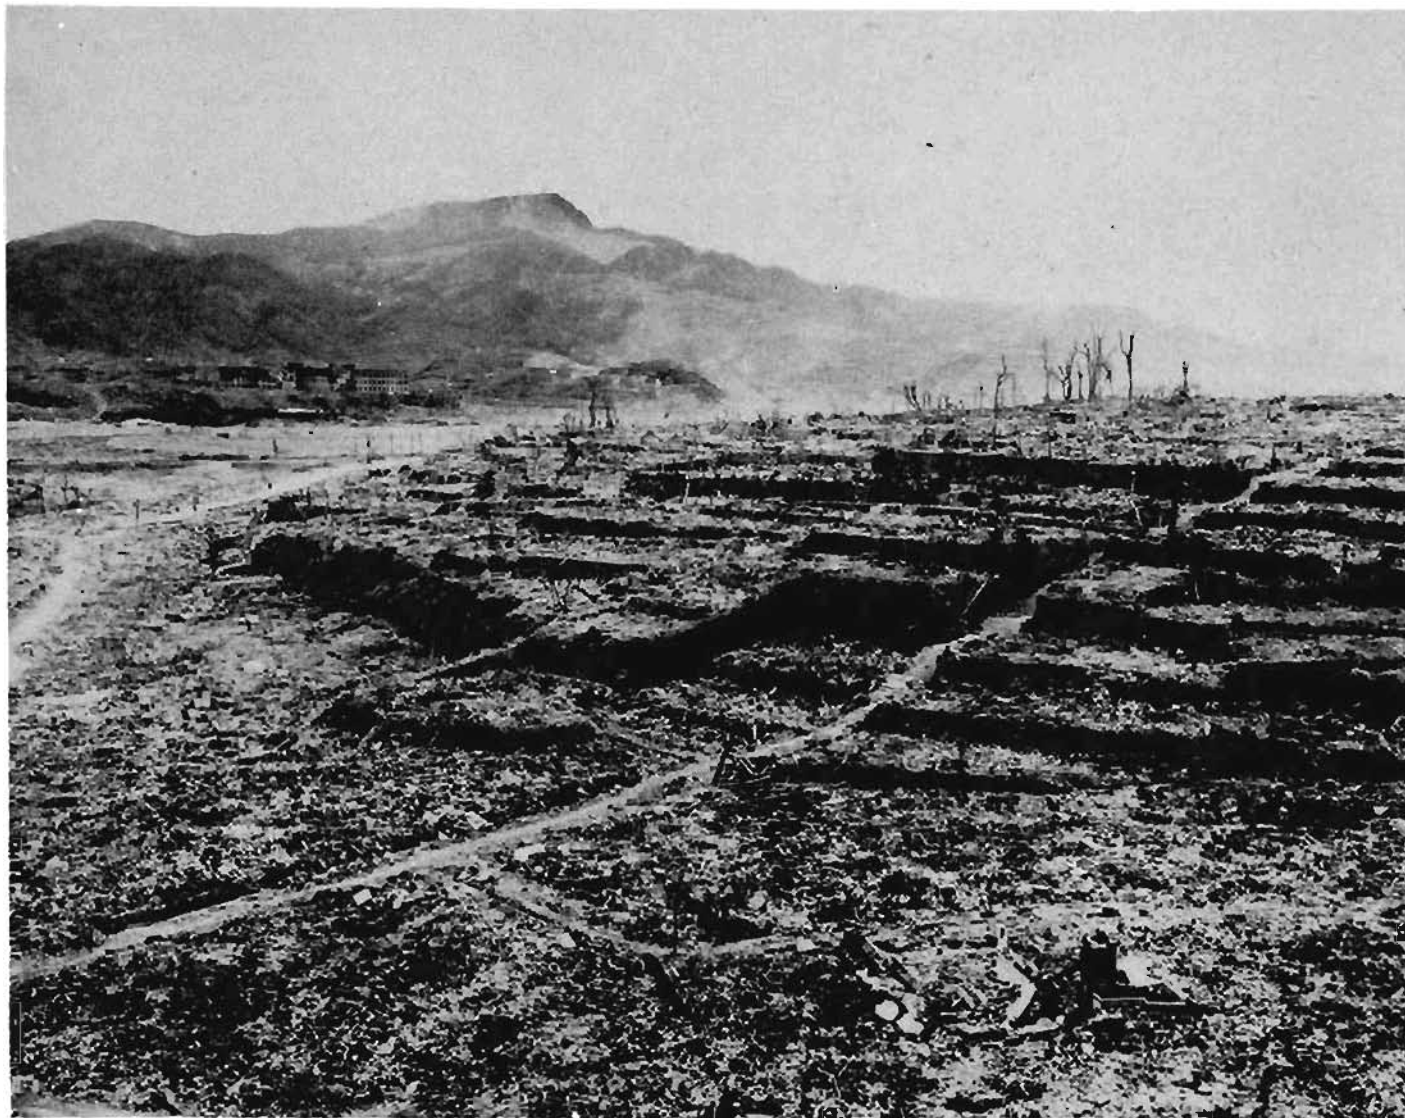
Figure 48

Panorama showing the general destruction in the industrial valley of Nagasaki, looking west from the Medical School and Hospital toward the reinforced concrete factory training school at the foot of the hills in the background. The north end of the Mitsubishi Steel and Arms Works can be seen in the middle portion of the picture. The reinforced concrete chimney, though still vertical, was cracked by the blast. This area was covered with factories and homes. The tracks of the street railway trolley were covered with debris, but were not otherwise much damaged.

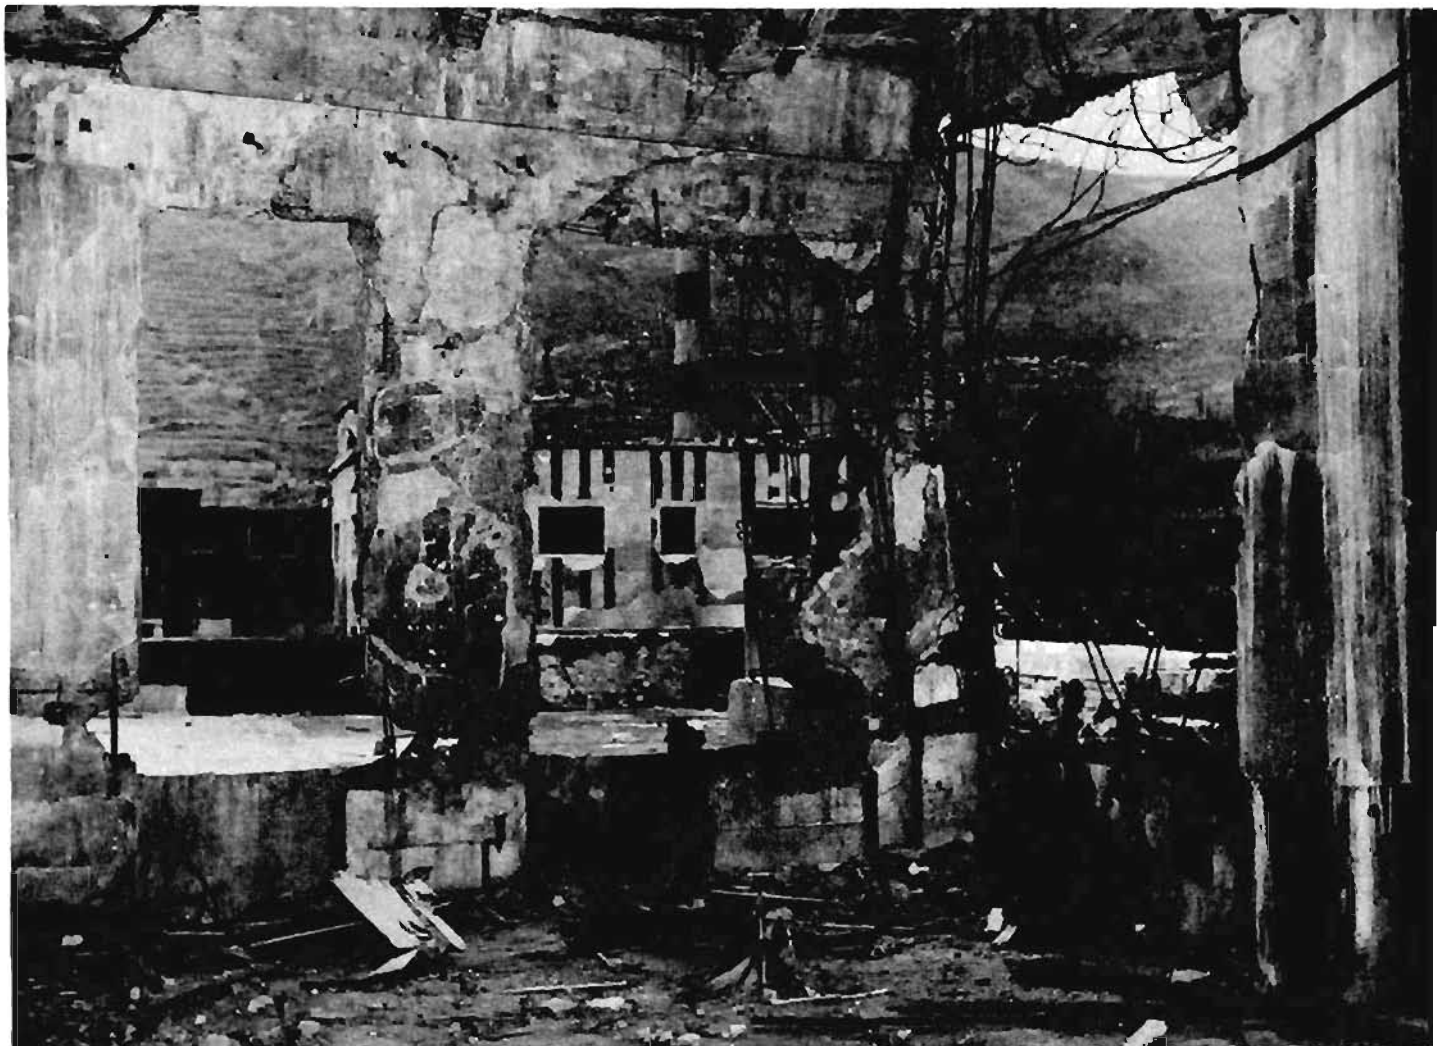
Figure 51

The Nagasaki Medical School and Hospital, from 0.4 to 0.55 mile southeast of X. This view shows one of the court yards, and several of the buildings of modern construction. The first building on the left (far end - second story) was hit by a bomb eight days before the atomic bomb hit Nagasaki.

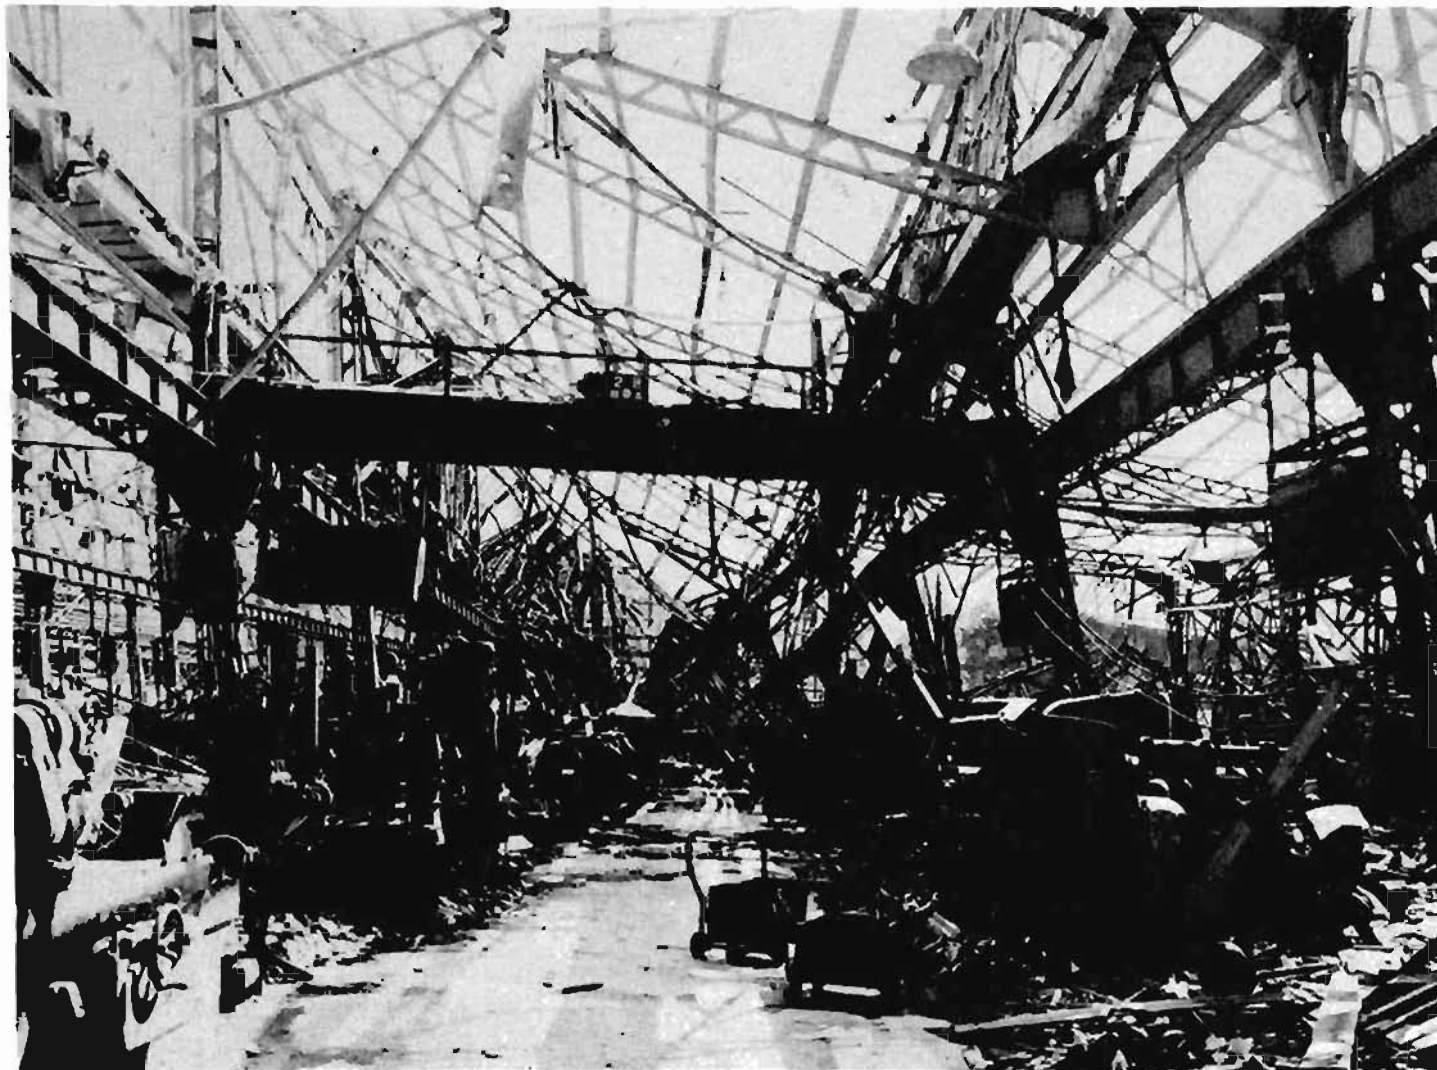
Figure 61

A shop building approximately 0.9 miles from X, in the Mitsubishi-Urakami Ordnance Works. This building was a total loss. The extremely light steel construction and the extensive use of wood combined to form a very weak building.

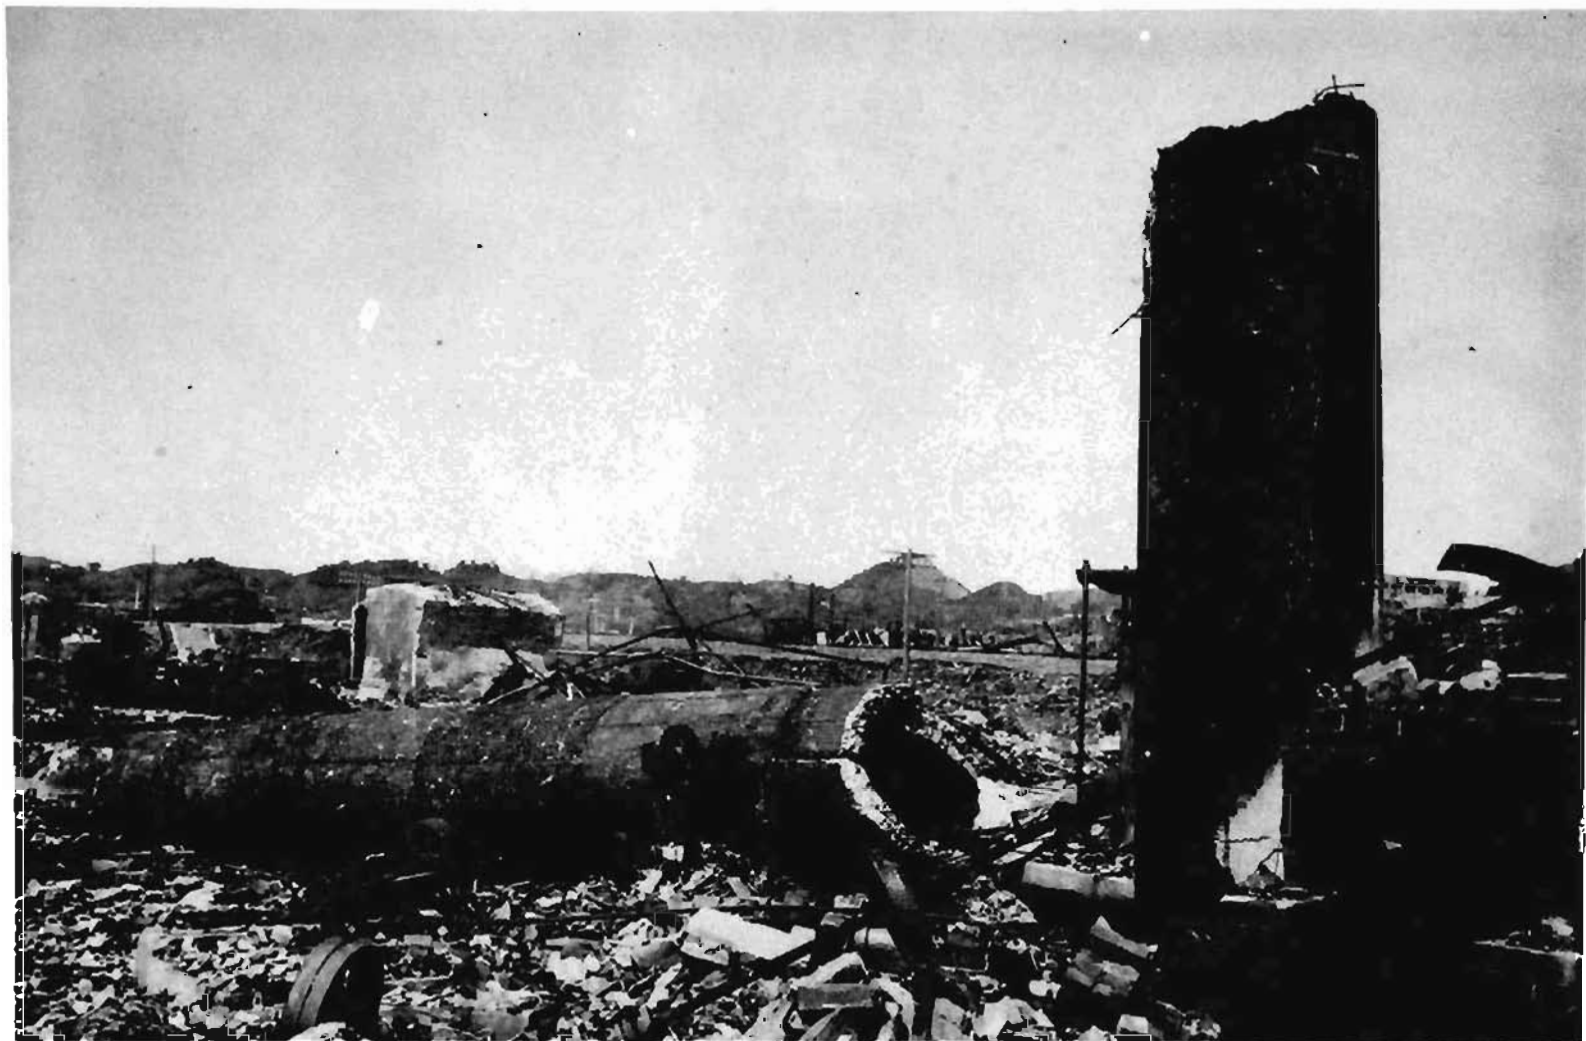
Figure 63

Wooden building 1.5 miles northeast of X in Nagasaki.

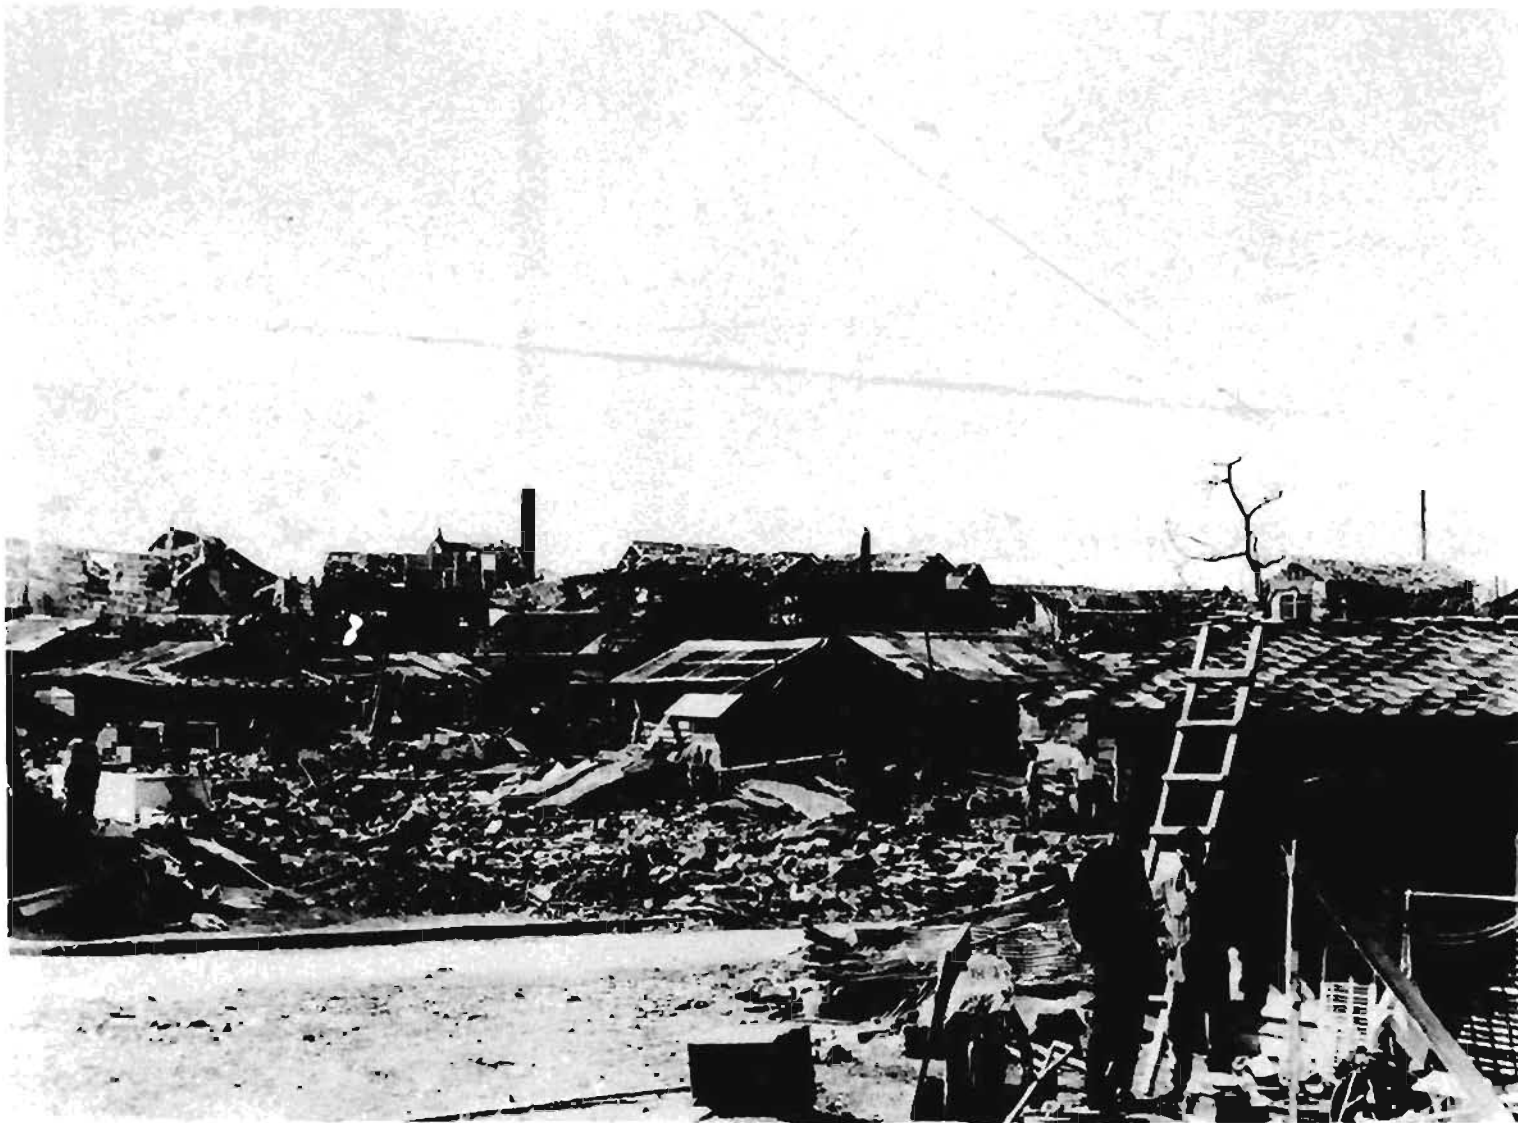
Figure 78

Hiroshima Panorama from a point 2,200 feet south of X.

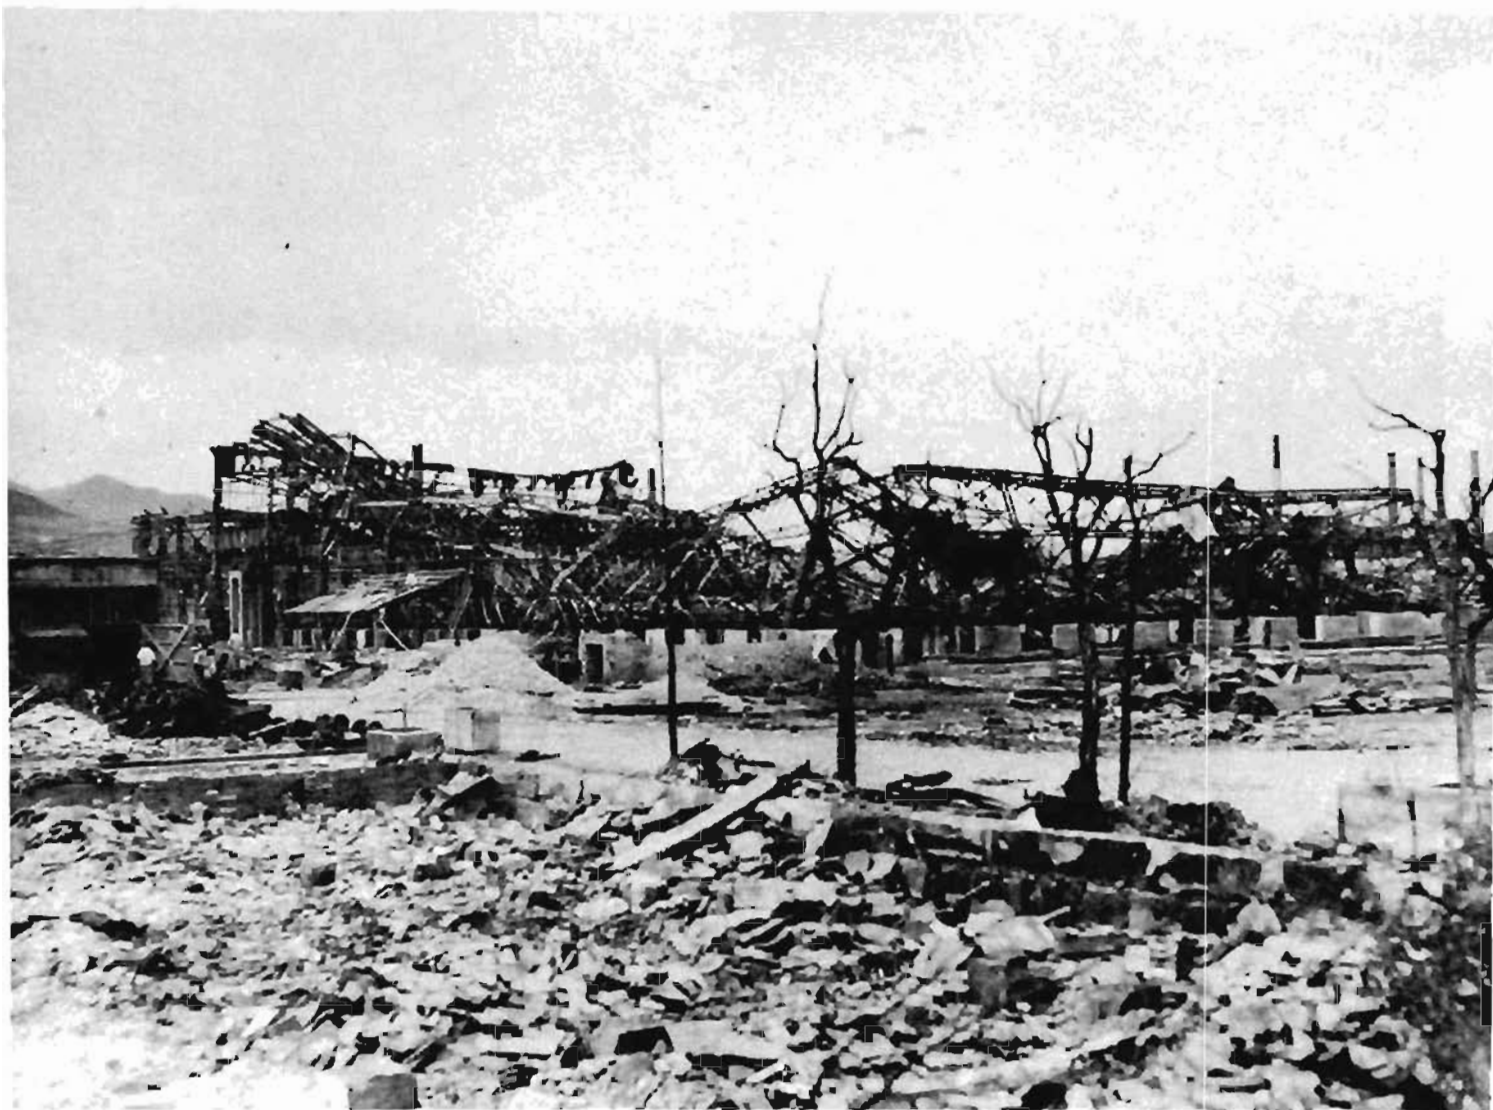
Figure 88

The remains of a small factory, 6,000 feet from X in Nagasaki.

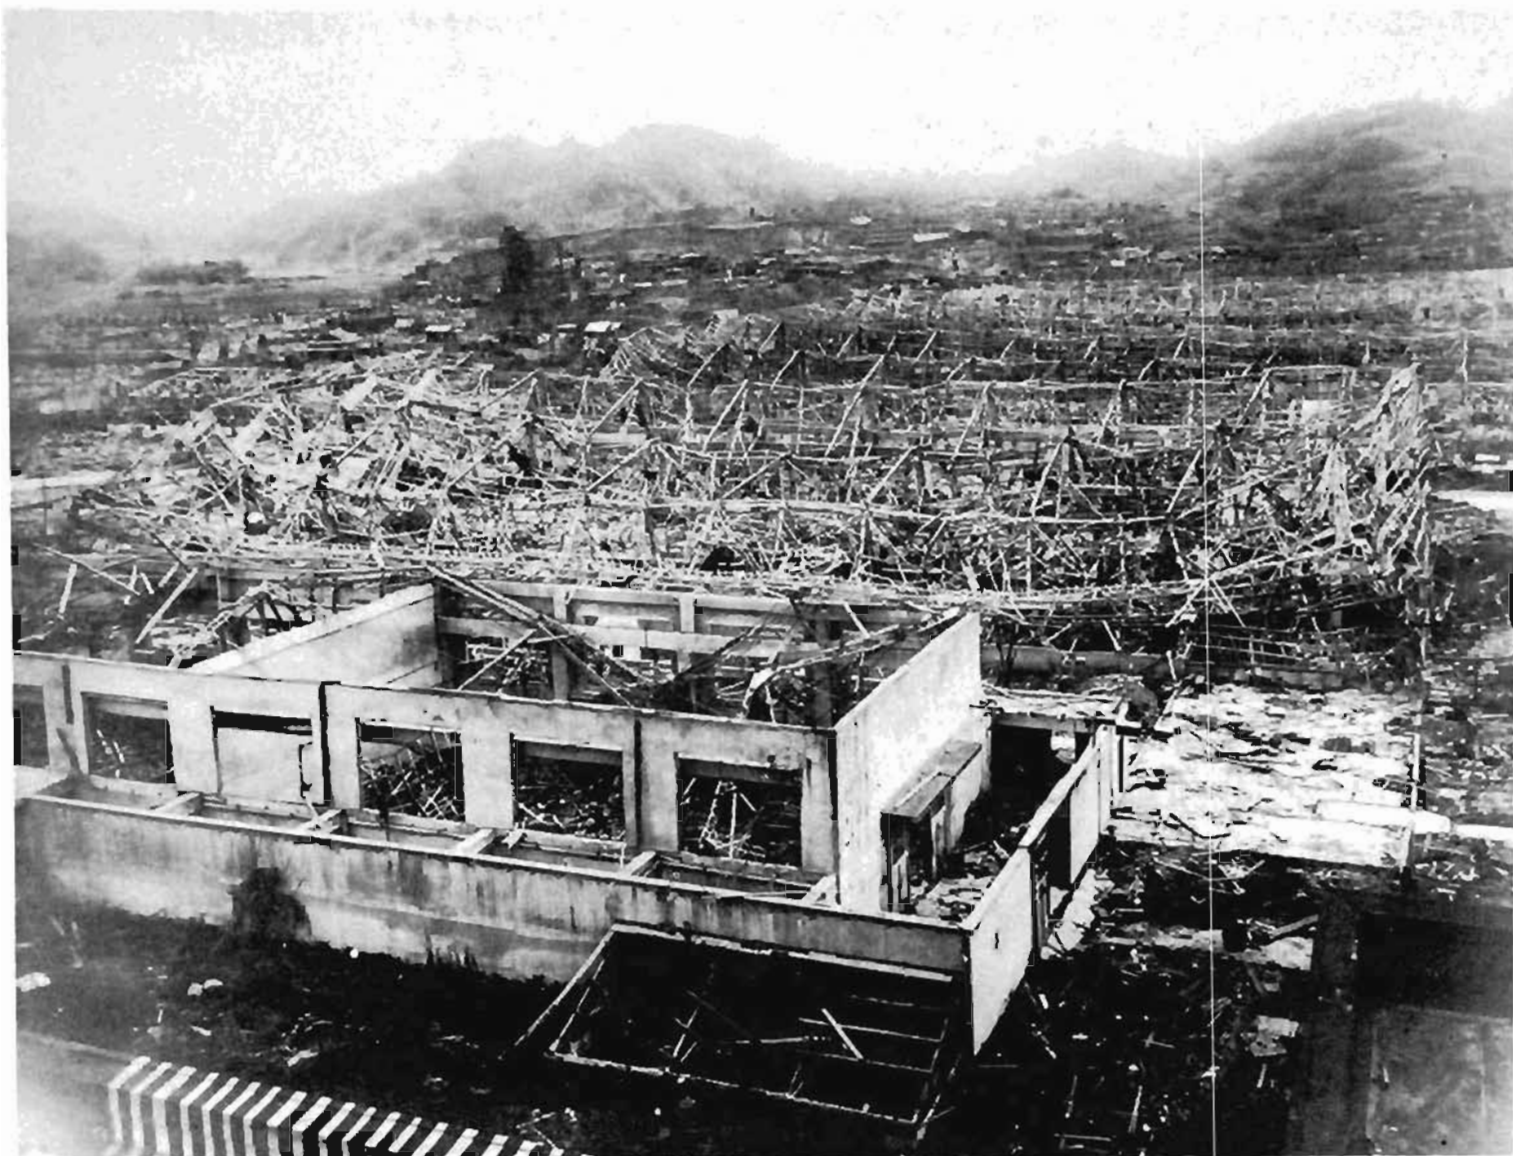
Figure 92

The Torpedo Works in Nagasaki.

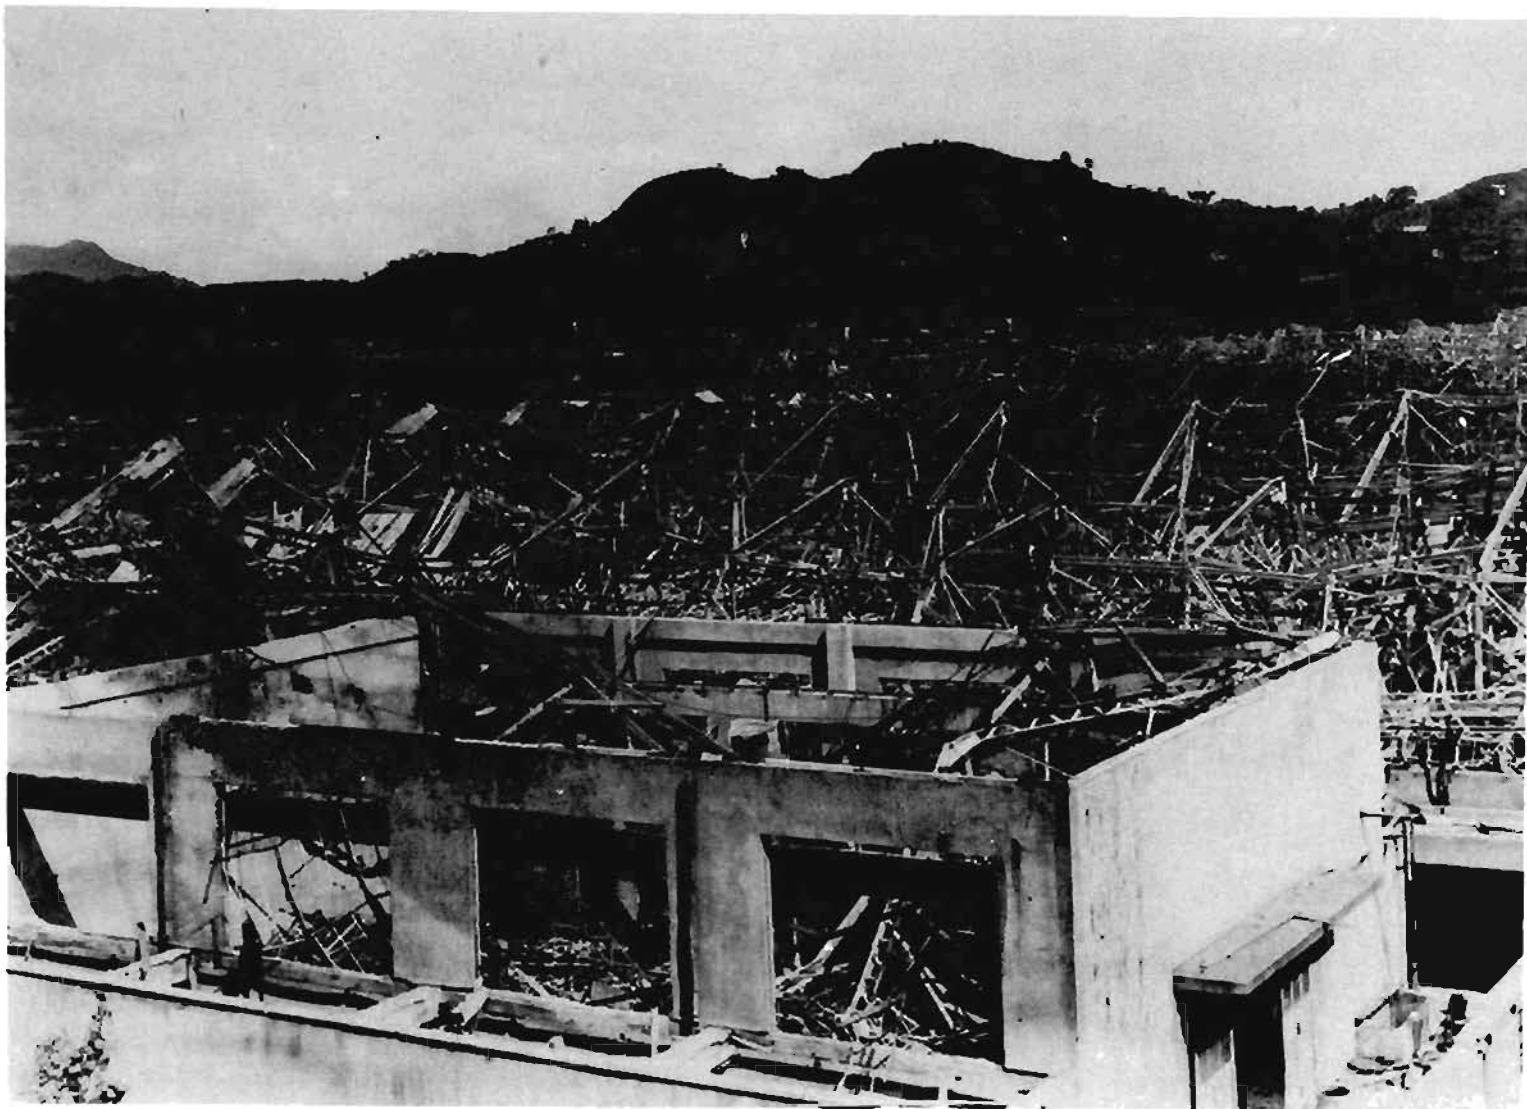
Figure 93

The Torpedo Works in Nagasaki, 4,200 feet from X.

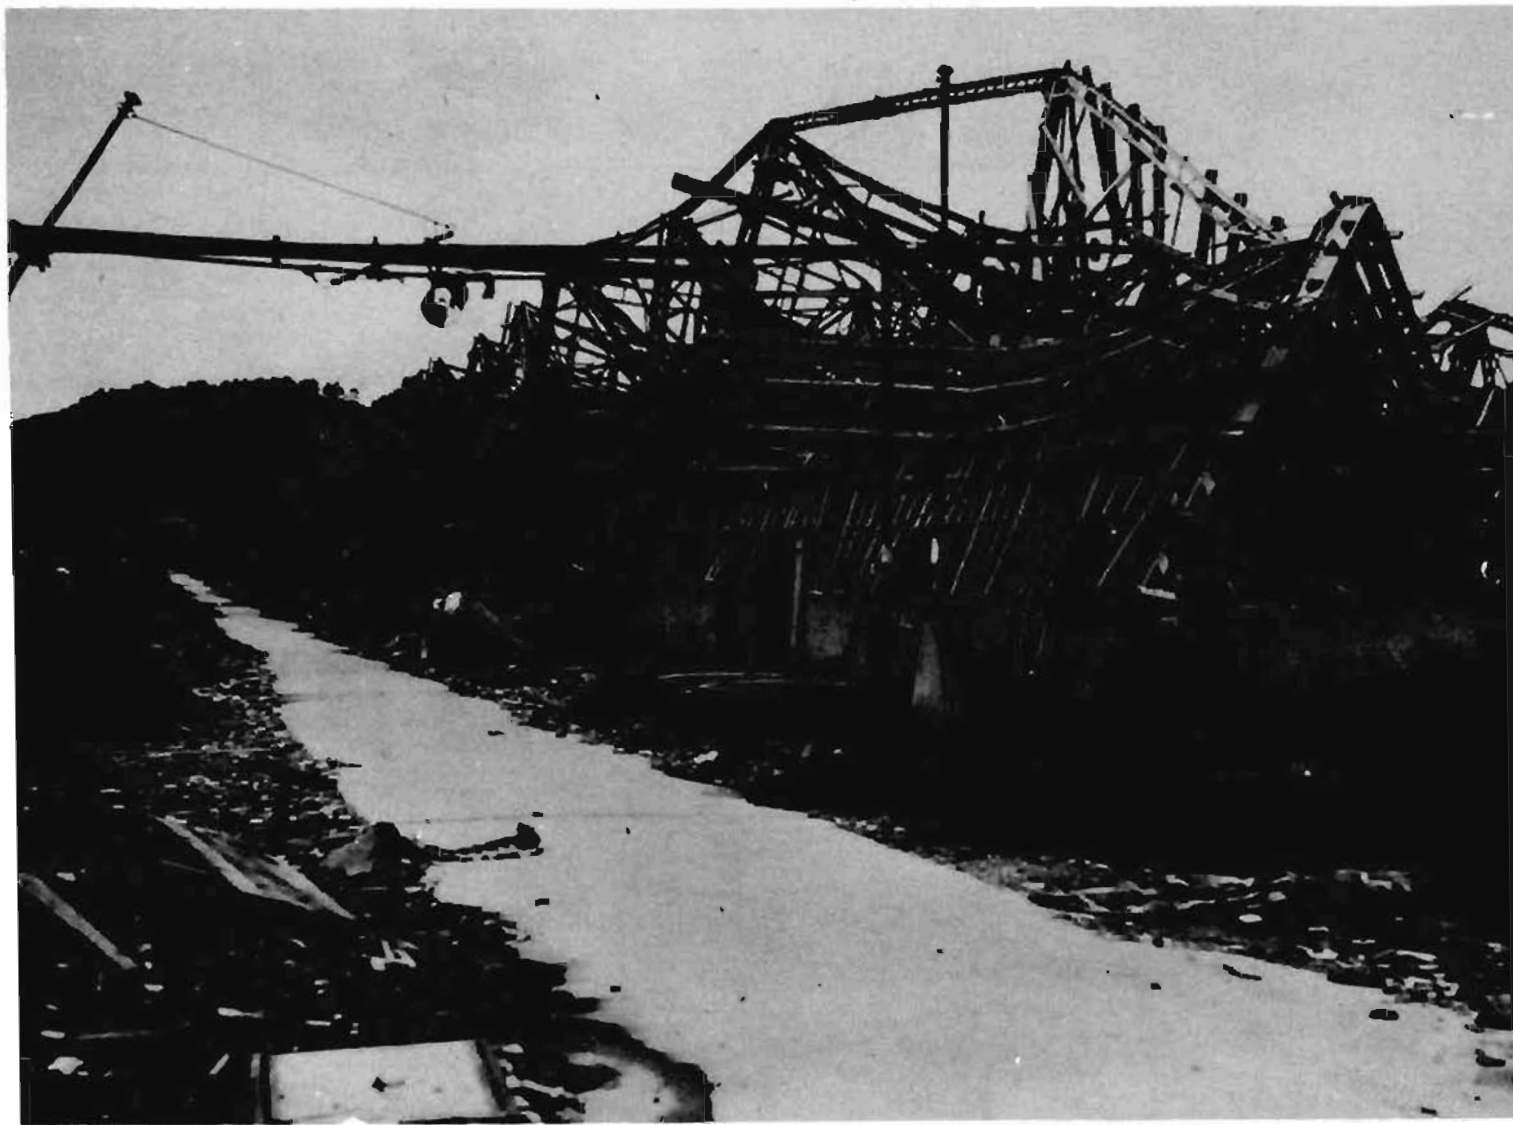
Figure 94

The Torpedo Works In Nagasaki, 4,200 feet north of X.
